**TOWN OF DUCK NORTH CAROLINA  
2020 SHORELINE & VOLUME CHANGE  
MONITORING REPORT**

**October 2020**

**TOWN OF DUCK  
2020 SHORELINE & VOLUME MONITORING REPORT**

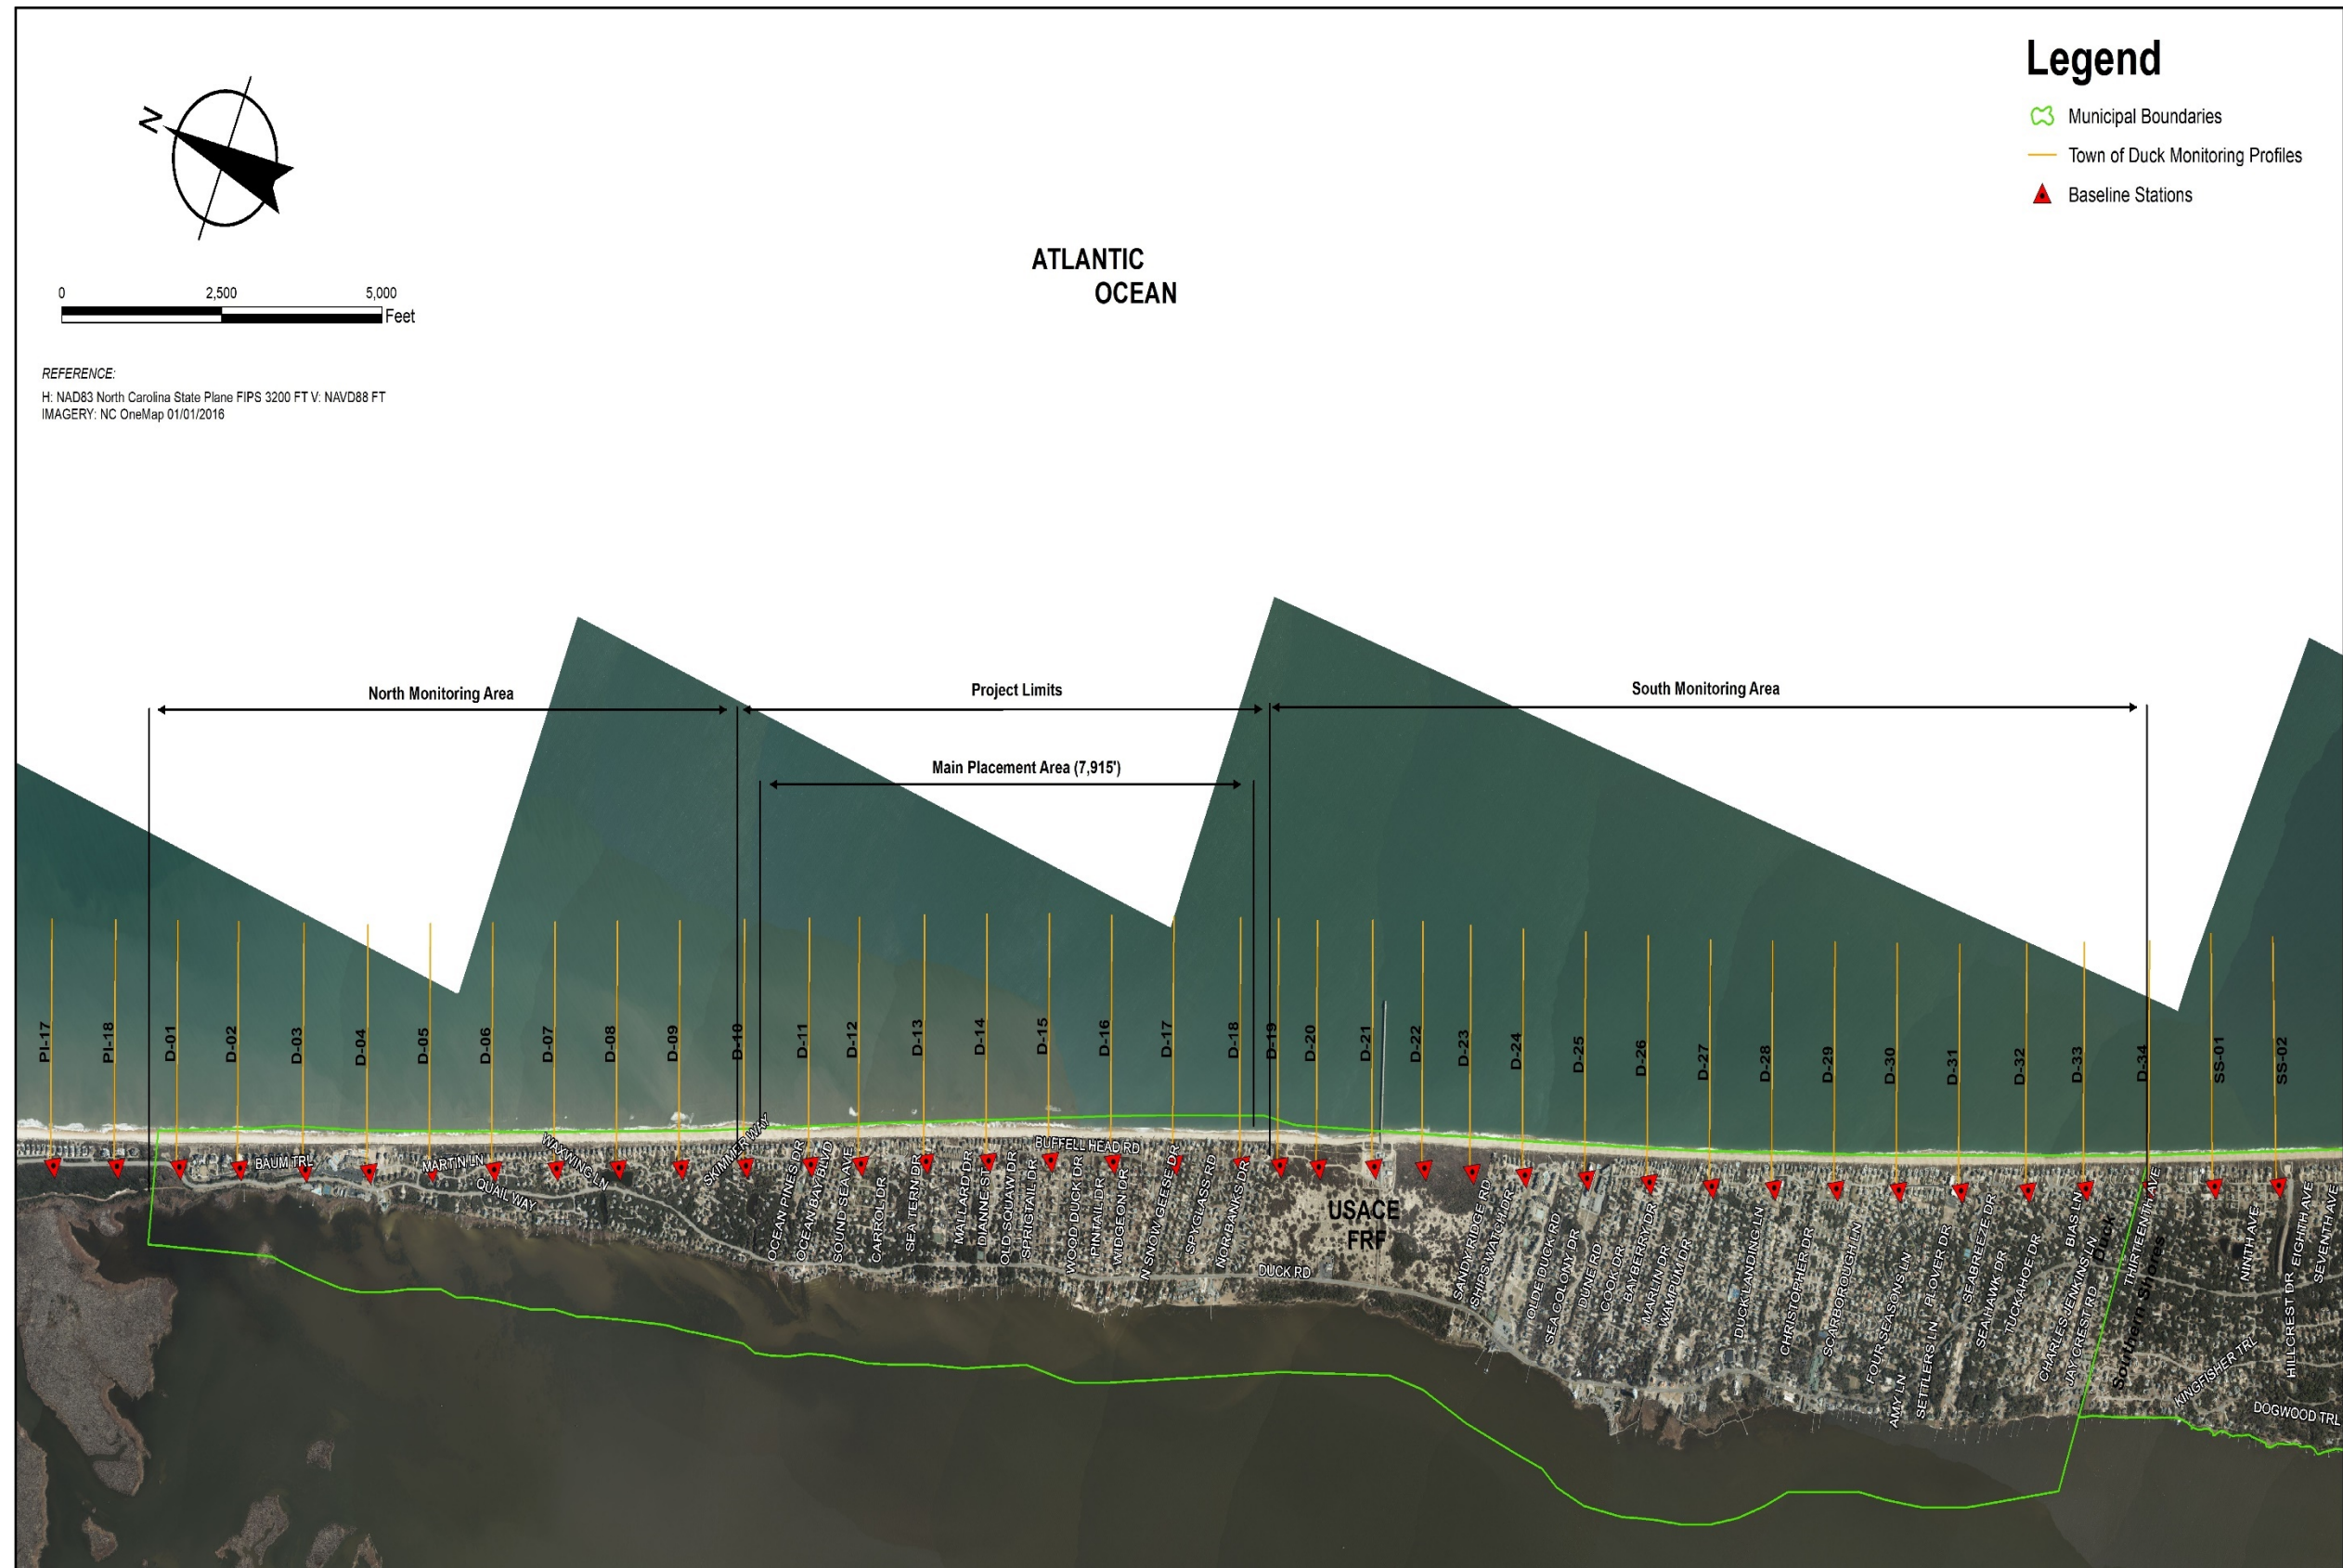
Figure 2. Detailed project area map showing the Project Area, North Monitoring Area, South Monitoring and the location of the monitoring profiles.

For the purpose of monitoring, this report has separated the oceanfront beach of Duck into three areas: namely, the Project Area and the areas North of the Project and South of the Project. These areas are depicted on Figure 2. The Project Area includes the beach between the northern FRF property line, located near station D-19, through station D-10, which is near the northern end of Skimmer Way. The section referred to as North of the Project extends from station D-10 (northern end of Skimmer Way) north to the Duck town limits (station D-01). The area designated South of the Project extends from station D-19 south to D-34 and includes the shoreline along the USACE FRF property. Profile D-34 is located near the Duck town boundary with the Town of Southern Shores. Figure 2 also depicts the stations at which beach profile surveys were conducted.

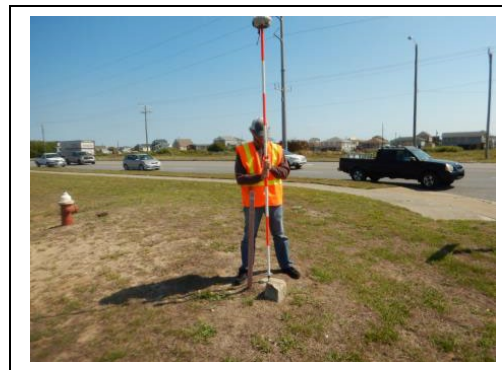
Monument: KITTY

Mean of Inverse Shots – Published Versus APTIM Found				
Monument	No. of Shots	$\Delta N$	$\Delta E$	$\Delta Z$
KITTY	33	0.00	-0.02	0.15
