2020 Town of Duck Topographic and Hydrographic Survey Report

Town of Duck

**Aptim Environmental & Infrastructure, LLC
2481 N.W. Boca Raton Blvd.
Boca Raton, FL 33431**

July 2020

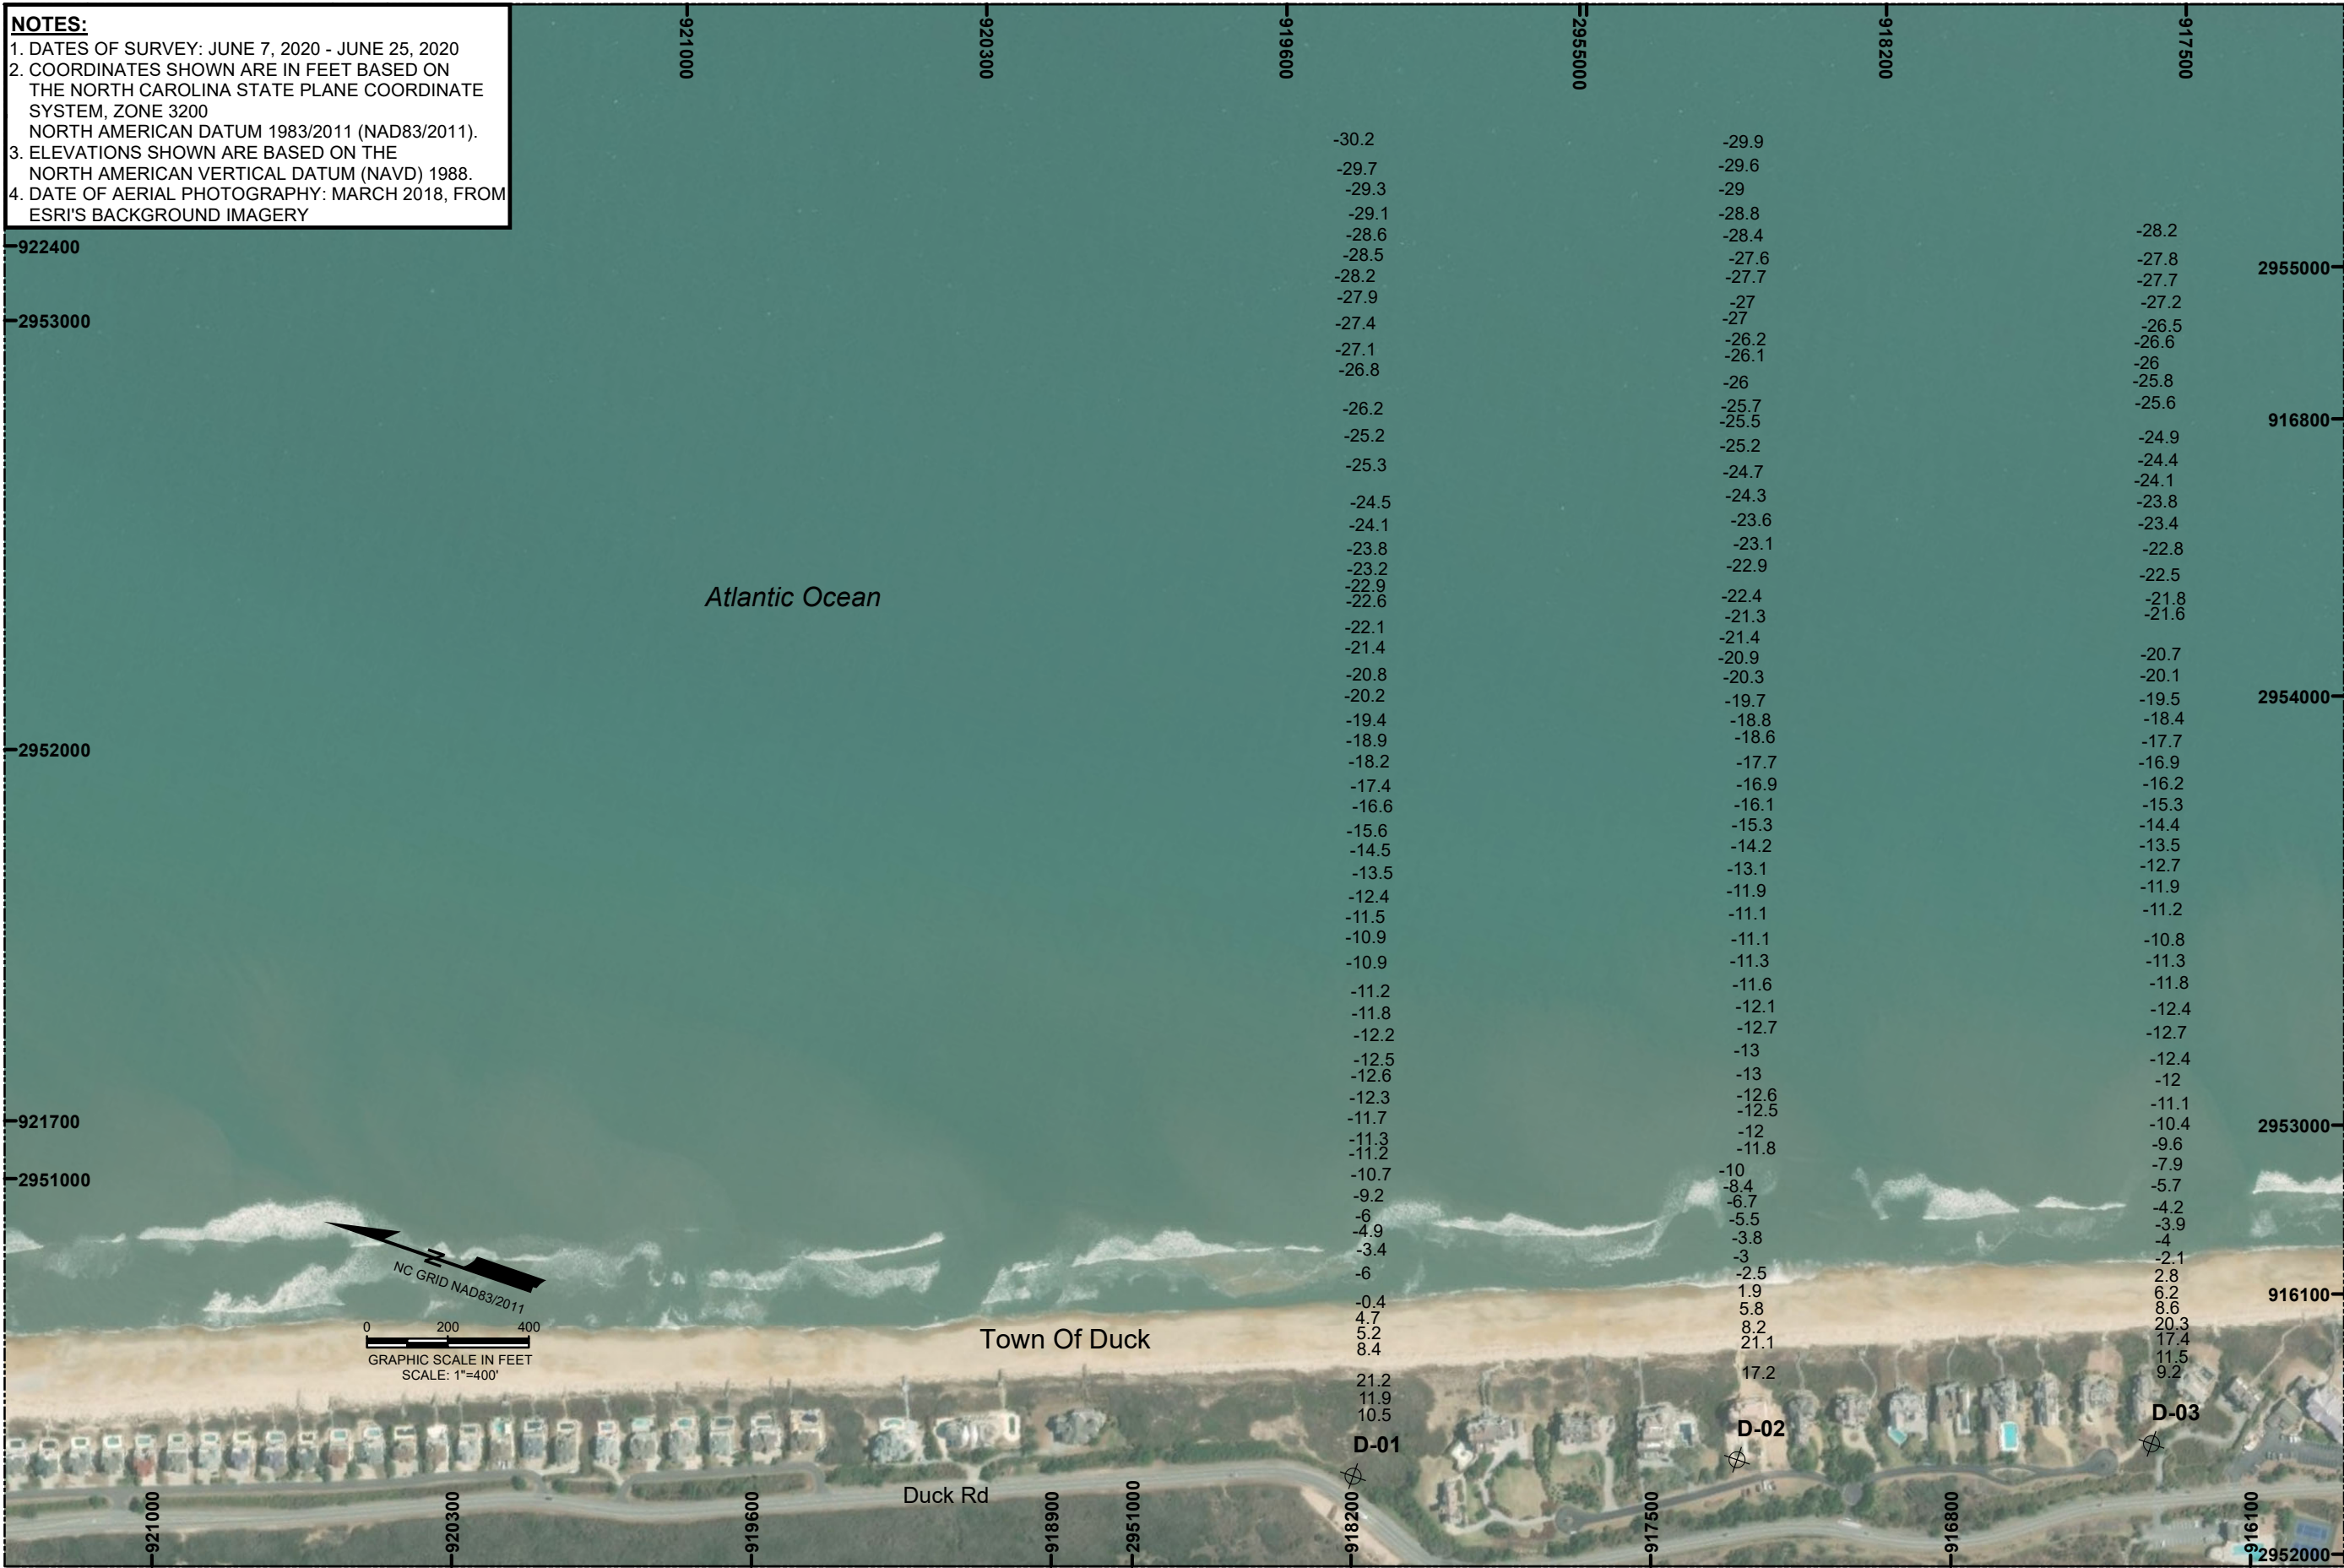
DRAWING NO.
PV-1

Upon completion of the surveys and data reduction, the survey maps were prepared in ArcGIS 10.7.1. In order to avoid congestion, the survey maps do not show all collected elevations, but enough to give an accurate depiction of the cross sections. The survey maps display profile data and control monument locations plotted against Esri's background aerial imagery from March, 2018.

PLAN VIEW

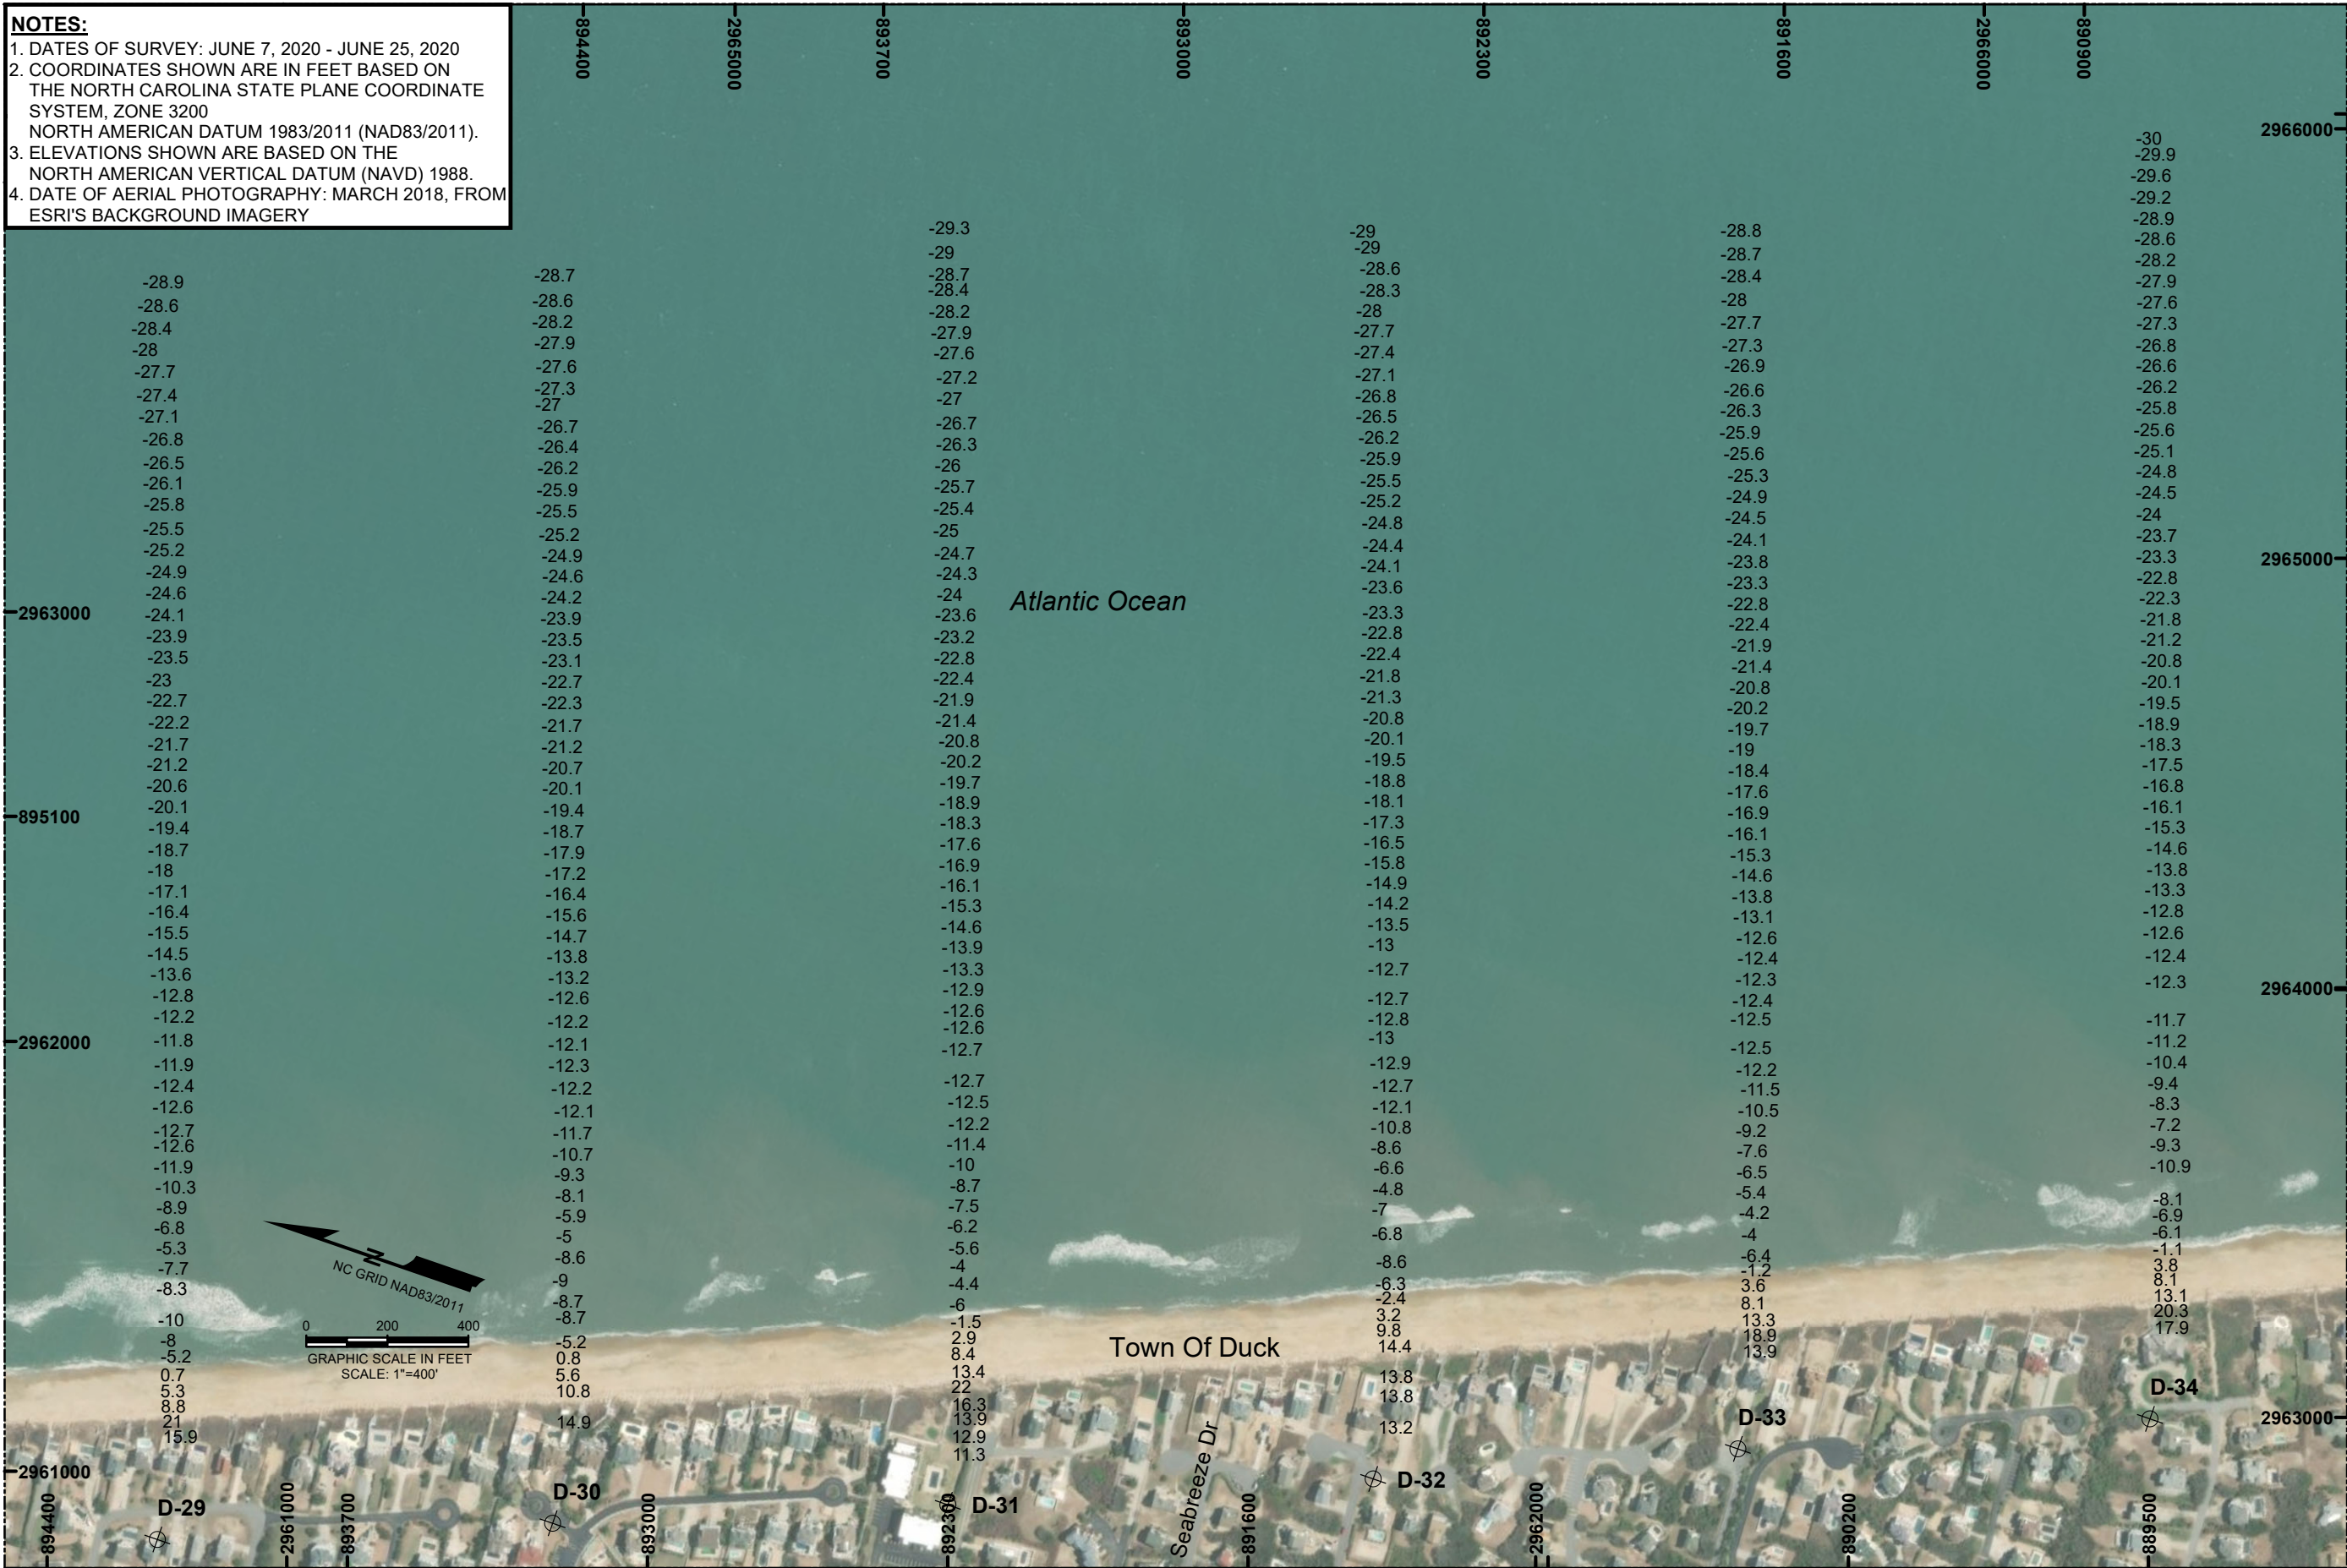
PLAN VIEW

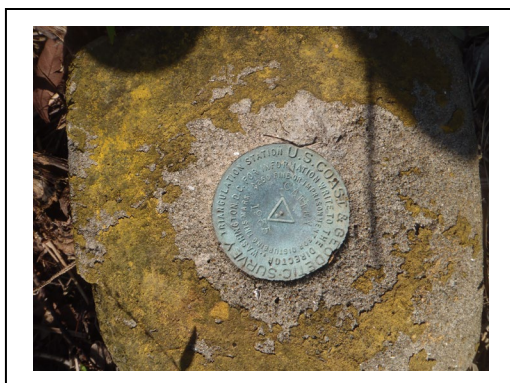
Monument: CAFFEY

CONTROL MONUMENT USED BY APTIM FOR 2020 TOWN OF DUCK TOPOGRAPHIC AND HYDROGRAPHIC SURVEY REPORT JUNE 2020	
DATUMS: NAD83(2011) - NAVD1988 (US SURVEY FEET)	
Designation	CAFFEY
Stamping	CAFFEY 1935
Northing	915308.87
Easting	2952084.11
Horizontal Root Mean Square Error	0.09
Elevation	1.99
Vertical Root Mean Square Error	0.05
Description	Station is about 350 feet W of Caffey Inlet Coast Guard Station, on a small sand neck which extends into the marsh on the E shore of Currituck Sound. This neck is just S of an old can buoy lying in the marsh and is just N of a small gut which the road crosses on a small bridge. The station is about 225 feet W of a flagpole at the fence line W of the coast guard station, a point in line with the S fence, and 179 feet NW of the center of the bridge.

Location Verification: CAFFEY

Mean of Inverse Shots – Published Versus APTIM Found				
Monument	No. of Shots	ΔN	ΔE	ΔZ
CAFFEY	31	-0.05	-0.02	0.04

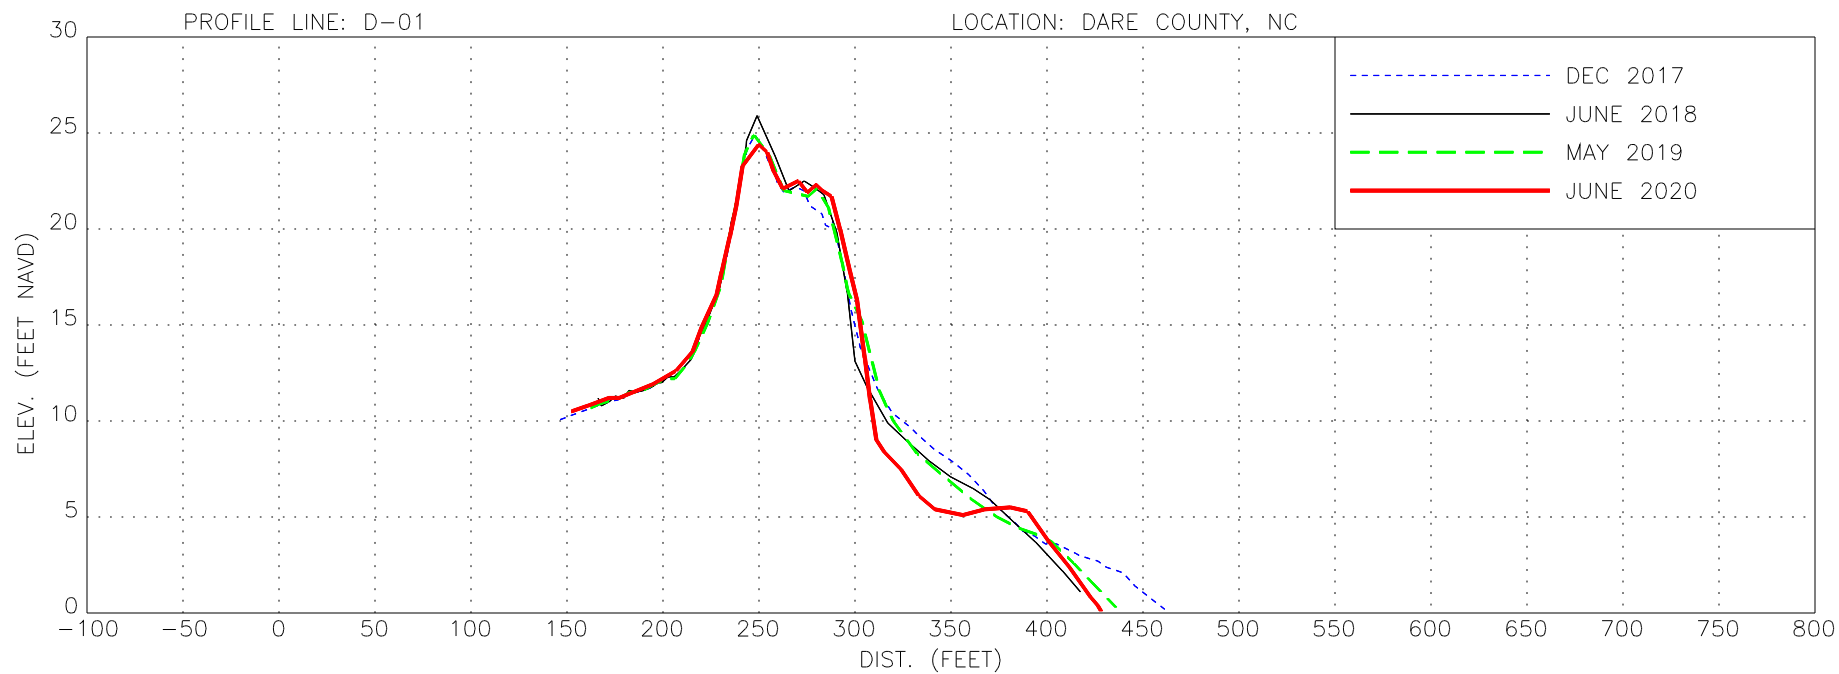
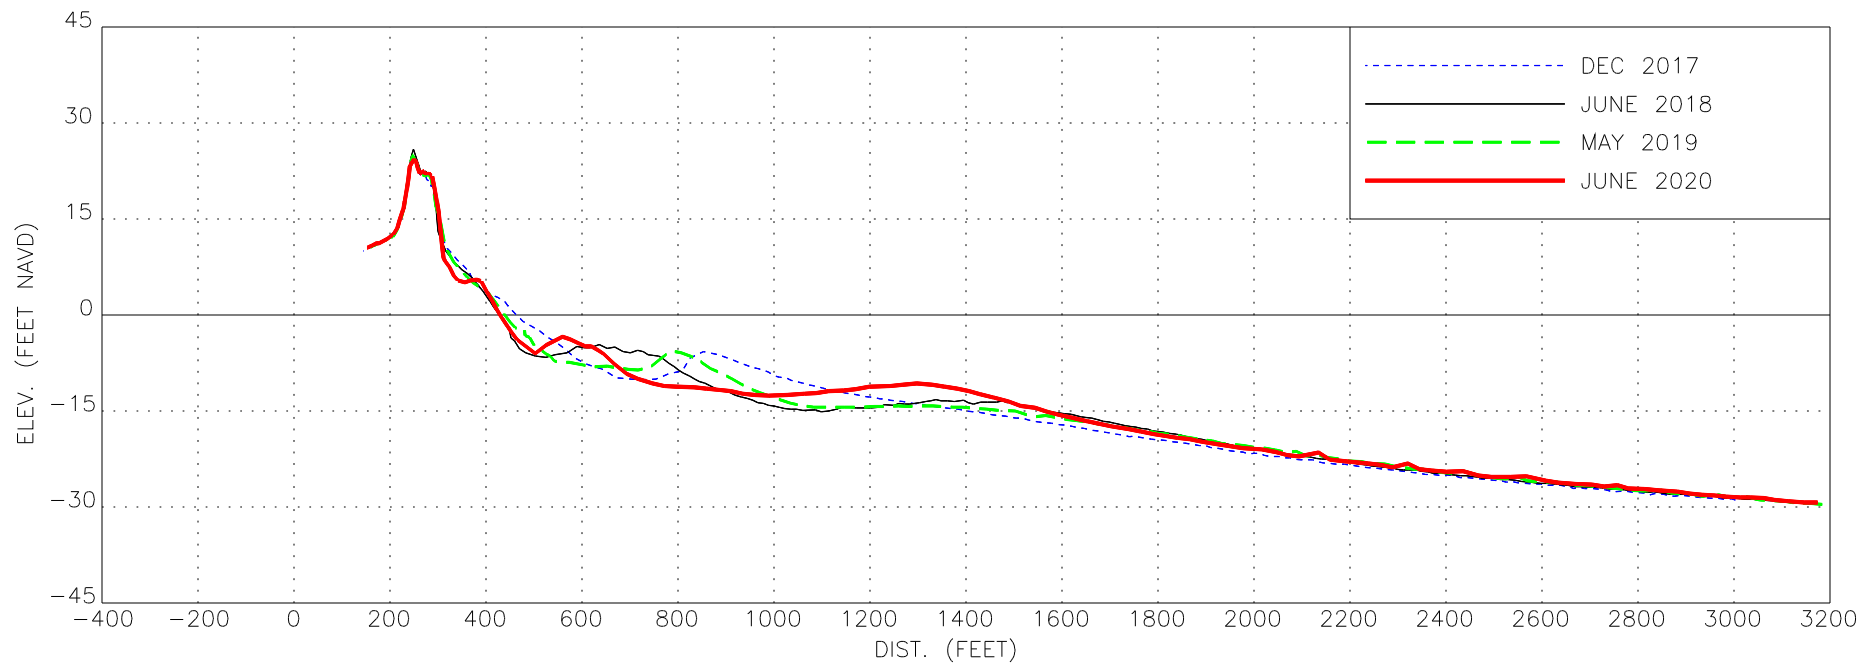
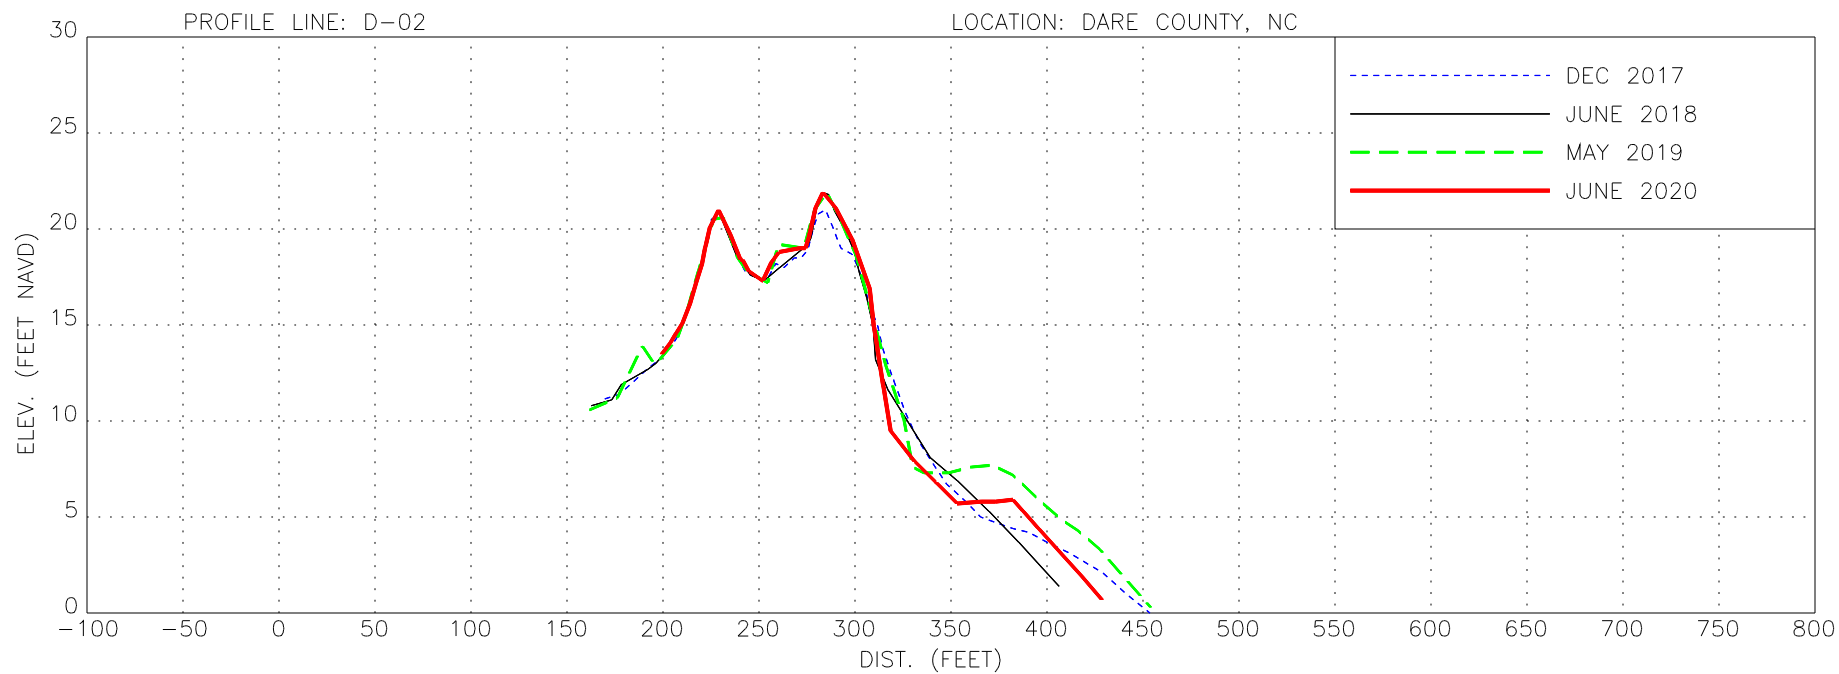
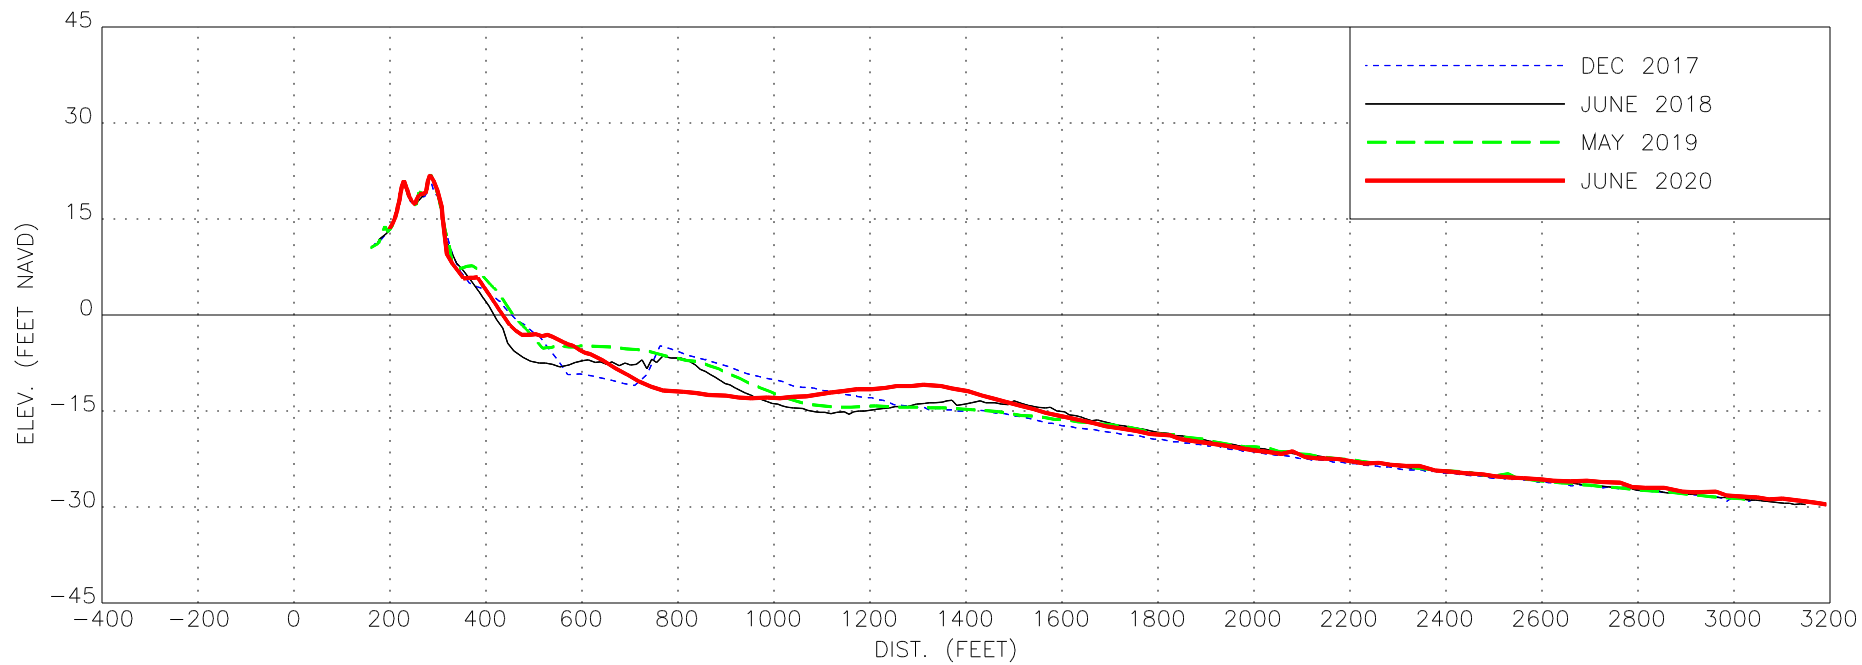
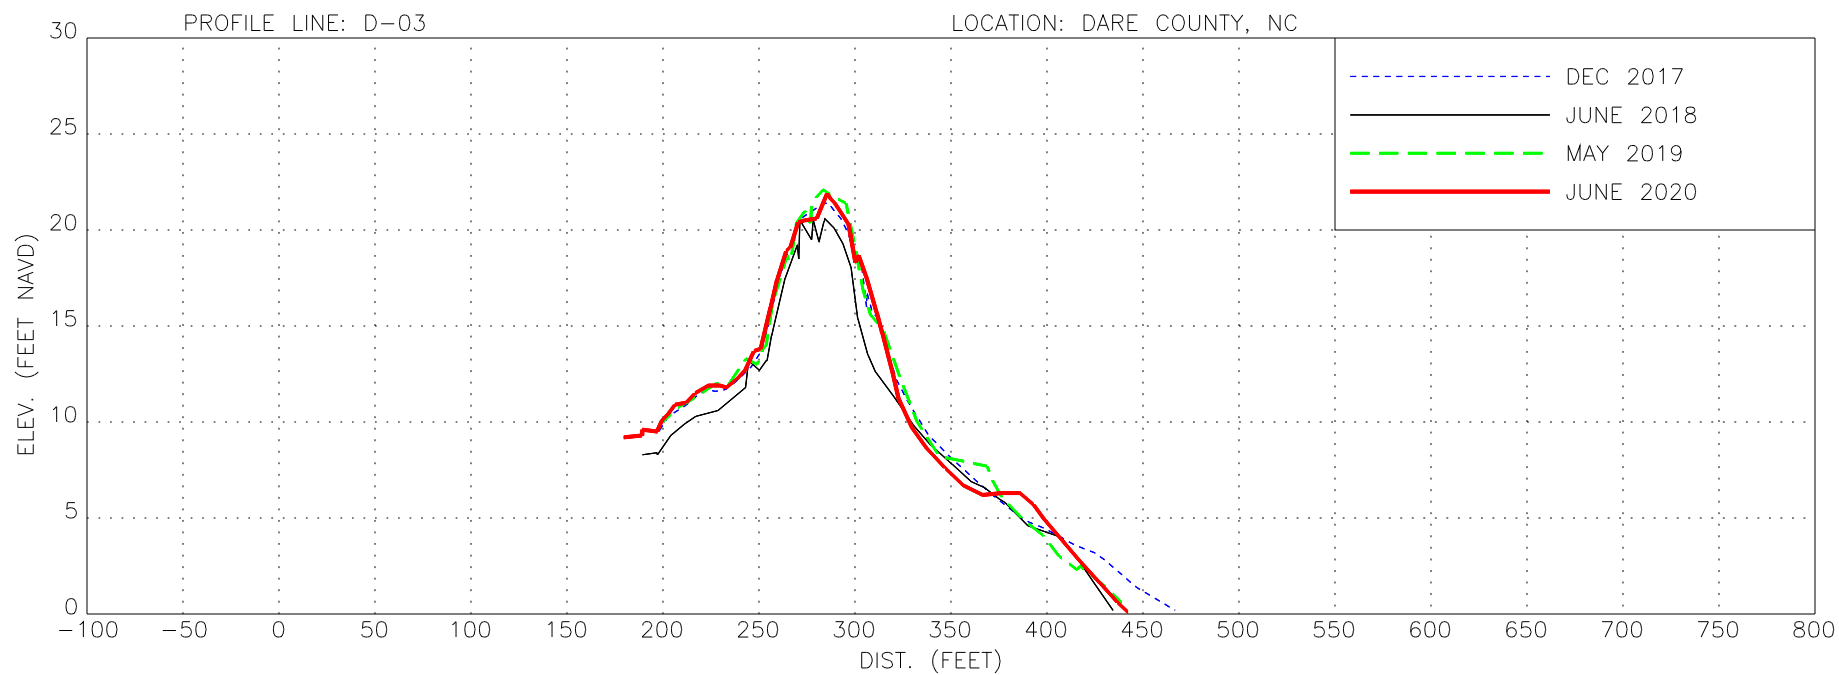
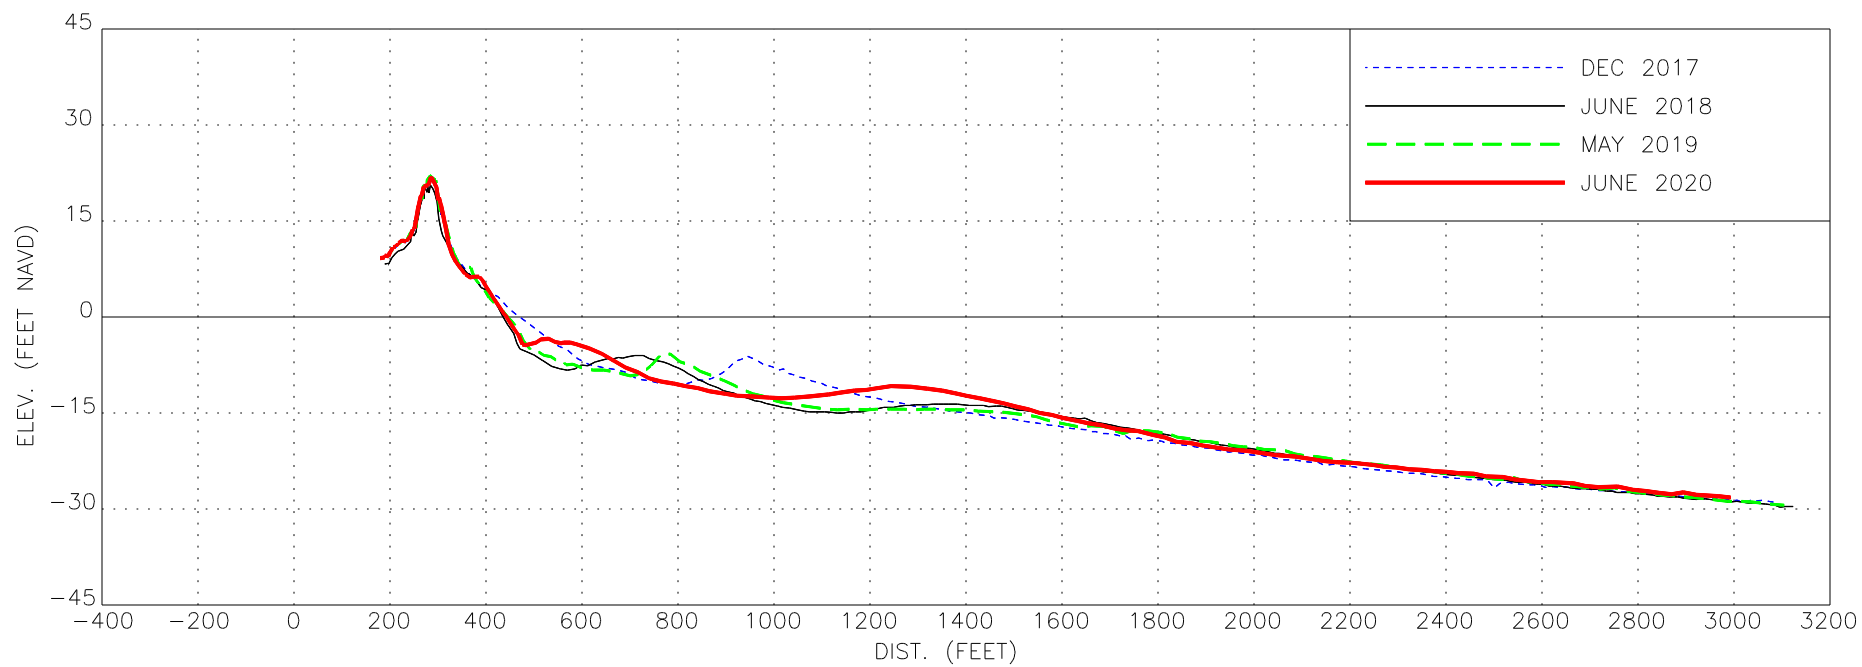
PROFILE PLOTS

The final plots were edited and reviewed with comparisons to previous years; discrepancies were noted and resolved. The final approved cross-section data was prepared in the required formats for submittal (**Appendix 3**). Digital data is provided in the State required vertical datum NAVD88.

Profile plots of this survey data compared with historical profile data.
