2018 Town of Duck Annual Monitoring Beach Profile Survey Report

Town of Duck, North Carolina

**Aptim Coastal Planning & Engineering of North Carolina, Inc.
4038 Masonboro Loop Road
Wilmington, NC 28409**

September 2018

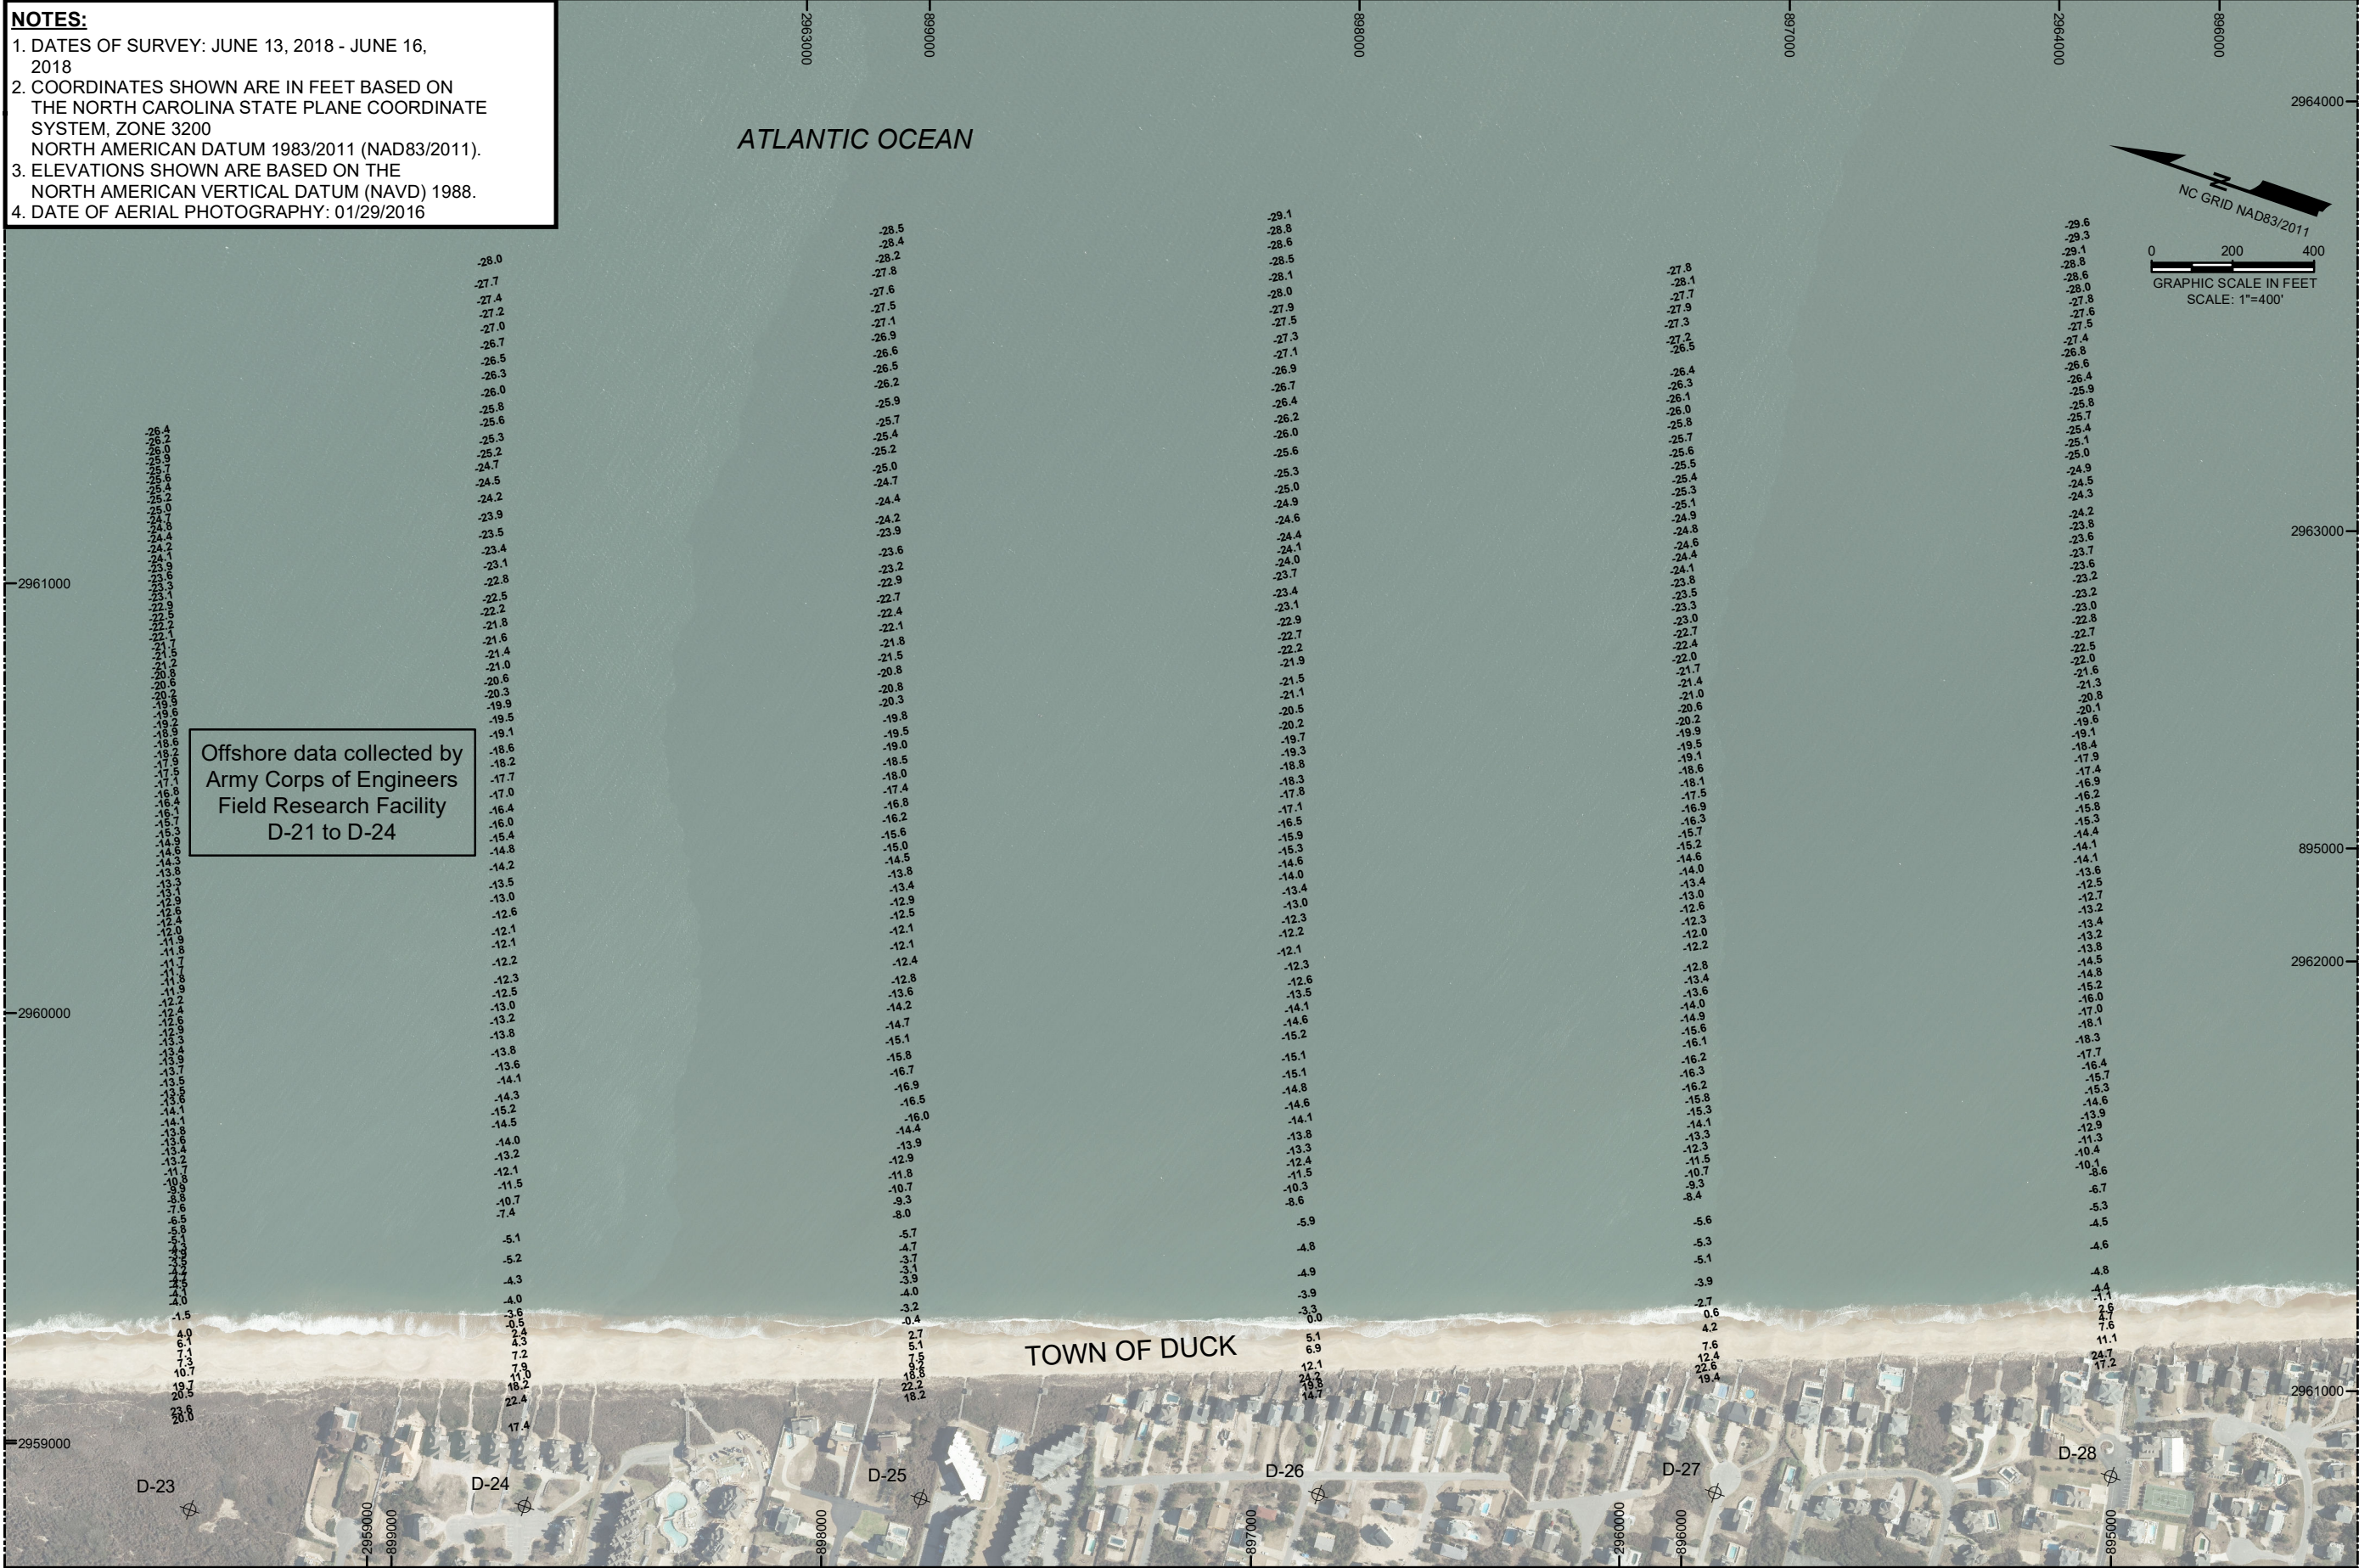
DRAWING NO.
PV-5

Offshore data collected by
Army Corps of Engineers
Field Research Facility
D-21 to D-24

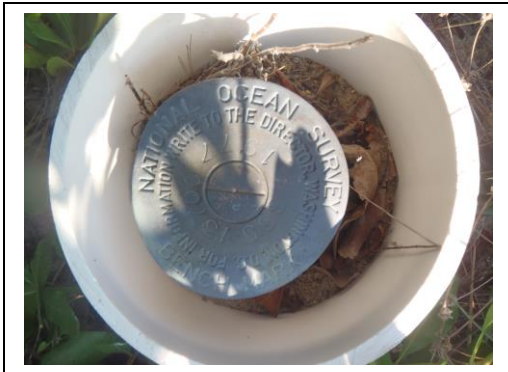
Monument: TIDAL C

Mean of Inverse Shots – OPUS Solution Versus APTIM Found				
Monument	No. of Shots	ΔN	ΔE	ΔZ
TIDAL C	10	0.05	0.12	0.00
