**FINAL: TOWN OF DUCK NORTH CAROLINA  
2018 SHORELINE & VOLUME CHANGE  
MONITORING REPORT**

**APTIM COASTAL PLANNING & ENGINEERING OF NORTH CAROLINA, INC.**

**September 2018**

# **TOWN OF DUCK 2018 SHORELINE & VOLUME MONITORING REPORT**

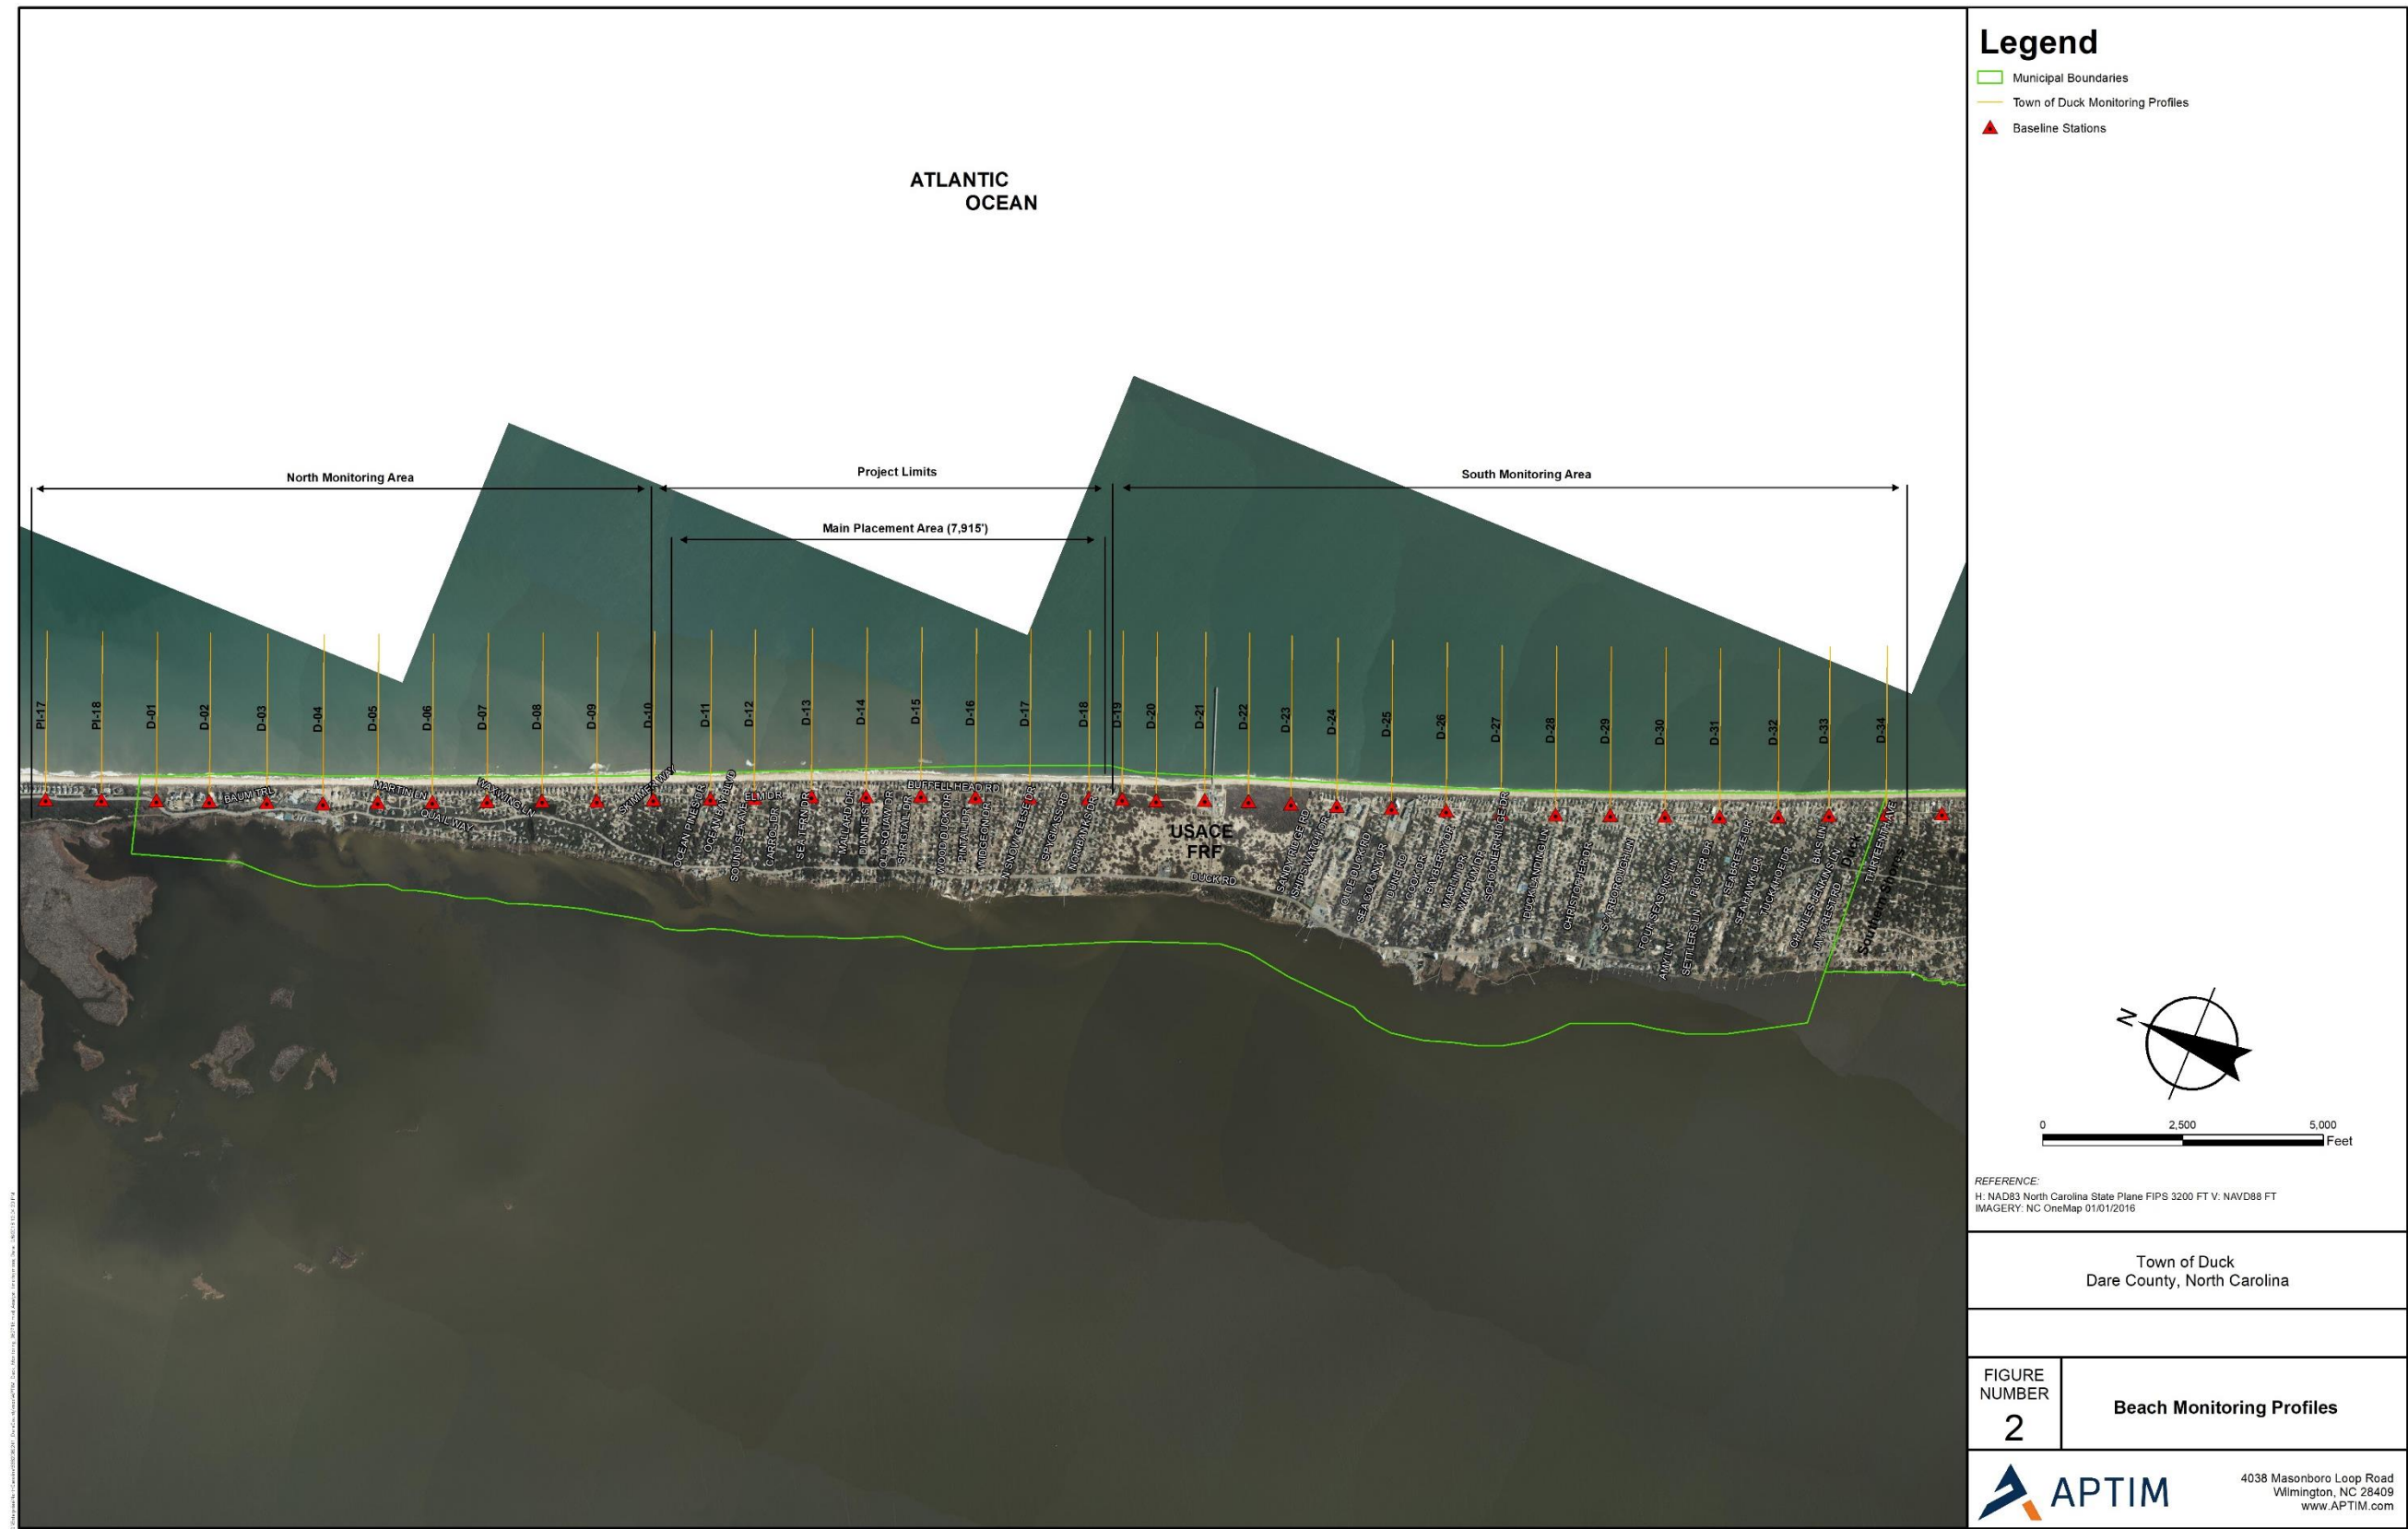
Figure 2. Detailed project area map showing the Project Area, North Monitoring Area, South Monitoring Area, and the location of the monitoring profiles.

The analysis described in this report focuses on assessing shoreline and volume changes within the limits of the beach nourishment project as well as the areas north and south of the project throughout the entirety of the Town. In this regard, the area north of the project includes profile stations D-01 to D-09 within the Duck town limits and 2,000 feet of shoreline on the south end of Pine Island (profile stations PI-17 and PI-18). The area south of the project includes profile stations D-20 to D-34. The map shown in Figure 2, depicts the project area, monitoring areas north and south of the project area, and the stations at which beach profile surveys were conducted.

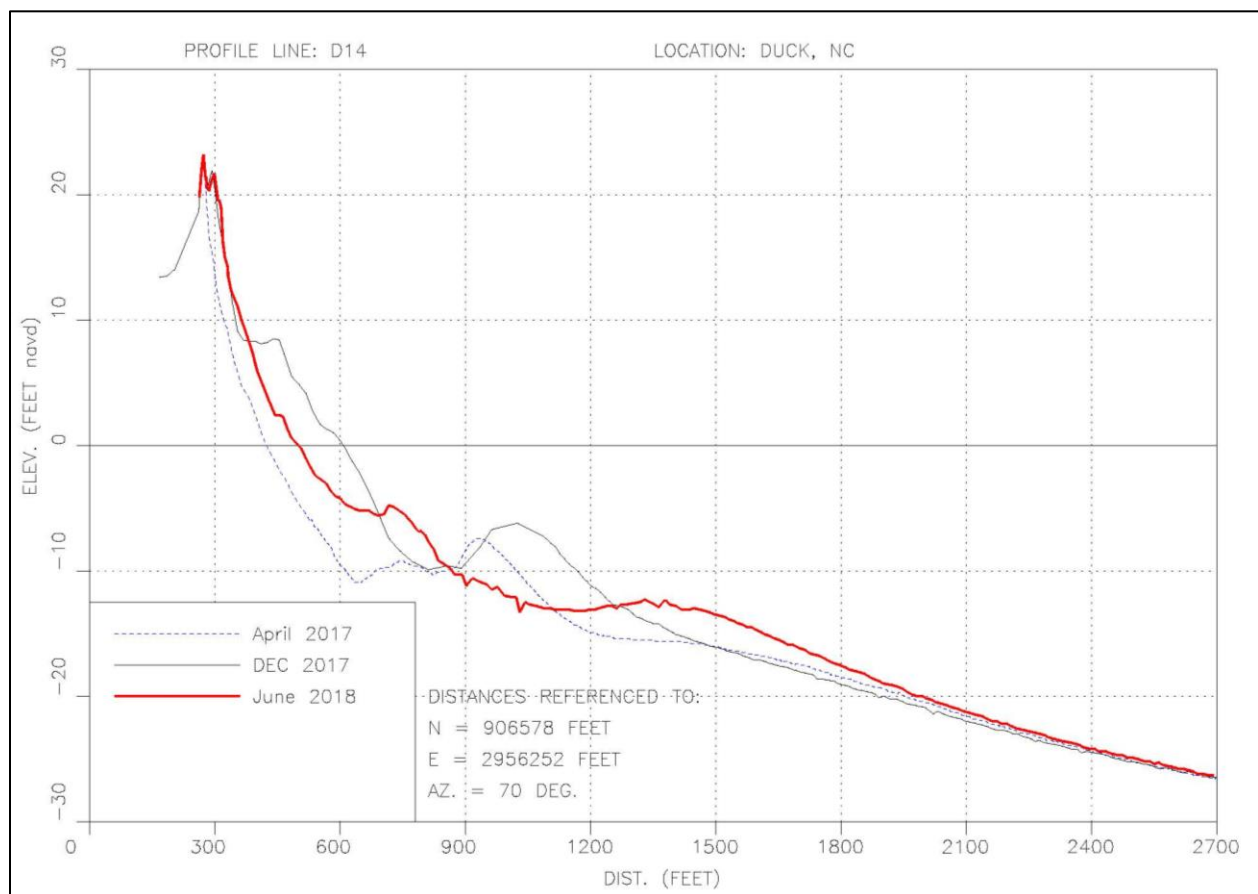
**Figure 5. Typical post-fill profile adjustments.**

The beach nourishment project constructed in 2017 extended the MHW line approximately 241 ft. seaward based on comparisons of the before dredge (BD) and after dredge (AD) surveys (APTIM, 2018B). However, these numbers should not be used in the determination of shoreline change analysis as these numbers represent the condition of the beach prior to any profile equilibration taking place. Based on a comparison of the April 2017 pre-construction survey and the December 2017 survey, the placement of the beach fill within the project area (D-10 to D-19) moved the mean high water (+1.2 ft. NAVD88) contour an average of approximately 111 feet seaward (APTIM, 2018B). This number is more reflective of the movement of the MHW shoreline as a result of the project, as it takes into account profile equilibration that took place between June 2017 and December 2017. From December 2017 to April 2018, the mean high water (MHW) shoreline receded an average of about 55 feet. The recession of the MHW shoreline during this period was associated with continued profile adjustments as material on the upper portion of the profile was moved seaward to deeper portions of the active profile. An example of this offshore movement of material is provided in Figure 5 for Profile D-14.

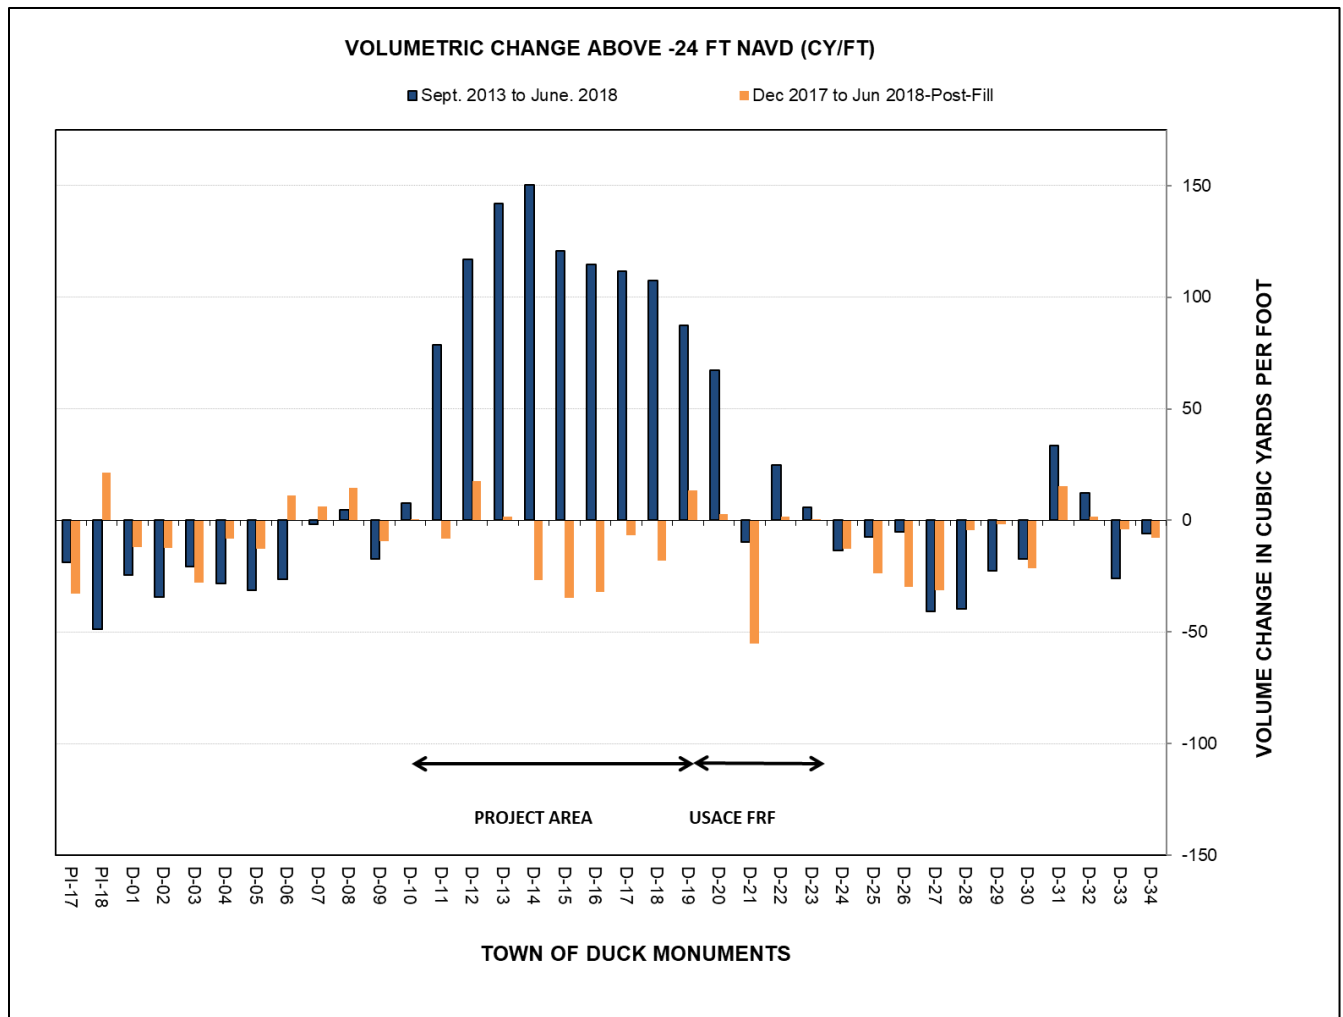
**Figure 7. Volume Changes (cubic yards/foot) measured between September 2013 and June 2018 and December 2017 and June 2018.**

The discussion of volume changes focuses on changes occurring within the beach nourishment project area (stations D-10 to D-19) as well as changes that are occurring north and south of the Project area. Figure 7 graphically depicts the volume changes measured between September 2013 and June 2018 as well as changes measured between December 2017 and June 2018.

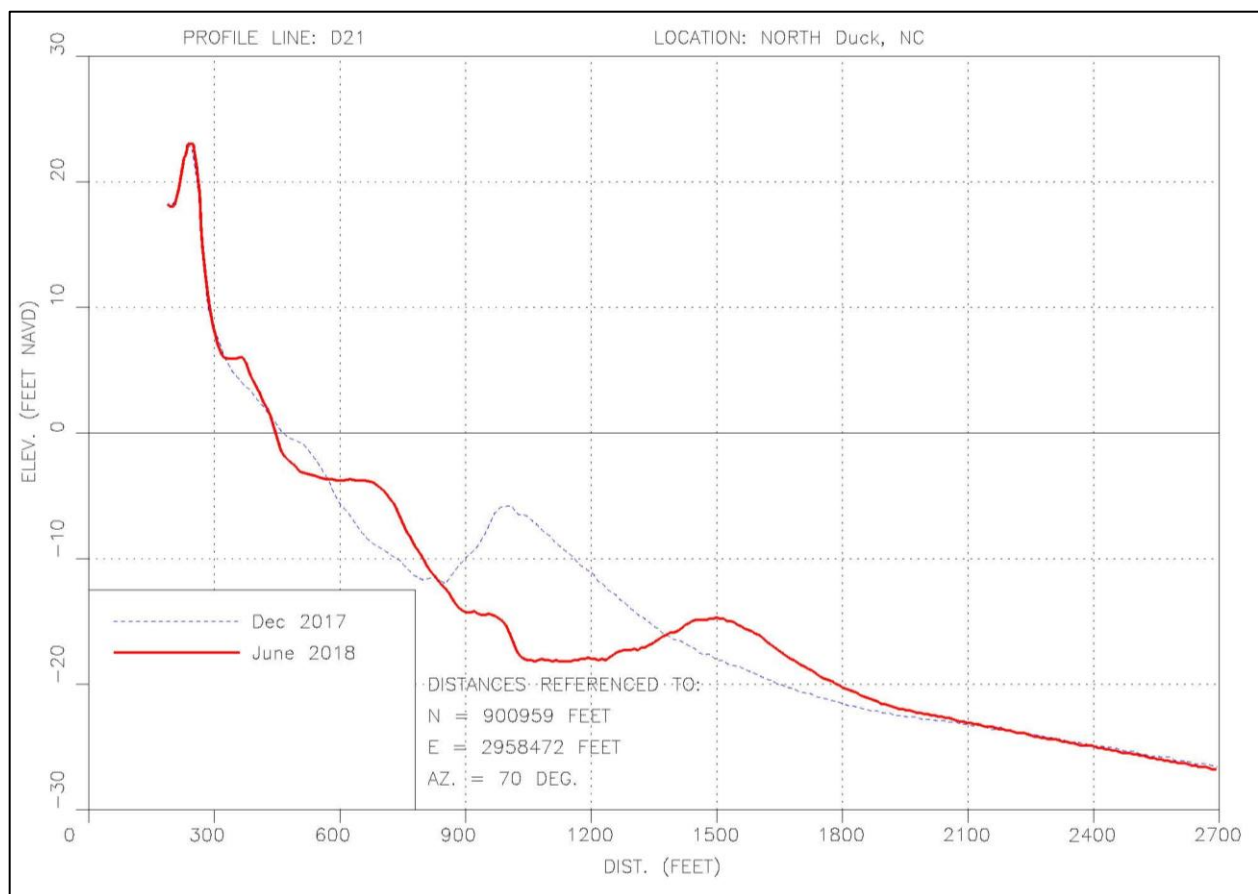
**Figure 8. Profile D-21 showing deep and wide trough measured during the June 2018 compared to December 2017 survey.**

at D-21 appear to be influenced by the truncation of the bar that was present in depths of 6 to 10 feet of water at the time of the December 2017 survey and the formation of a rather deep and wide trough in the same location as shown on Figure 8. While a similar truncation of the bar and formation of a trough occurred along most of the profiles along the Town of Duck between December 2017 and June 2018, the trough that formed along profile D-21 appears to be 4 to 6 feet deeper than those observed along adjacent profiles (see Appendix A). With profile D-21 located immediately north of the FRF pier, some of the profile changes at D-21 could have been influenced by the piles supporting the pier. The anomalous behavior of D-21 will be reexamined during the next monitoring survey to see if this feature persists or if it was just an ephemeral change that eventually disappeared over time. In any event, the behavior of D-21 prevents any definitive assessment as to possible southward spreading of the fill material.

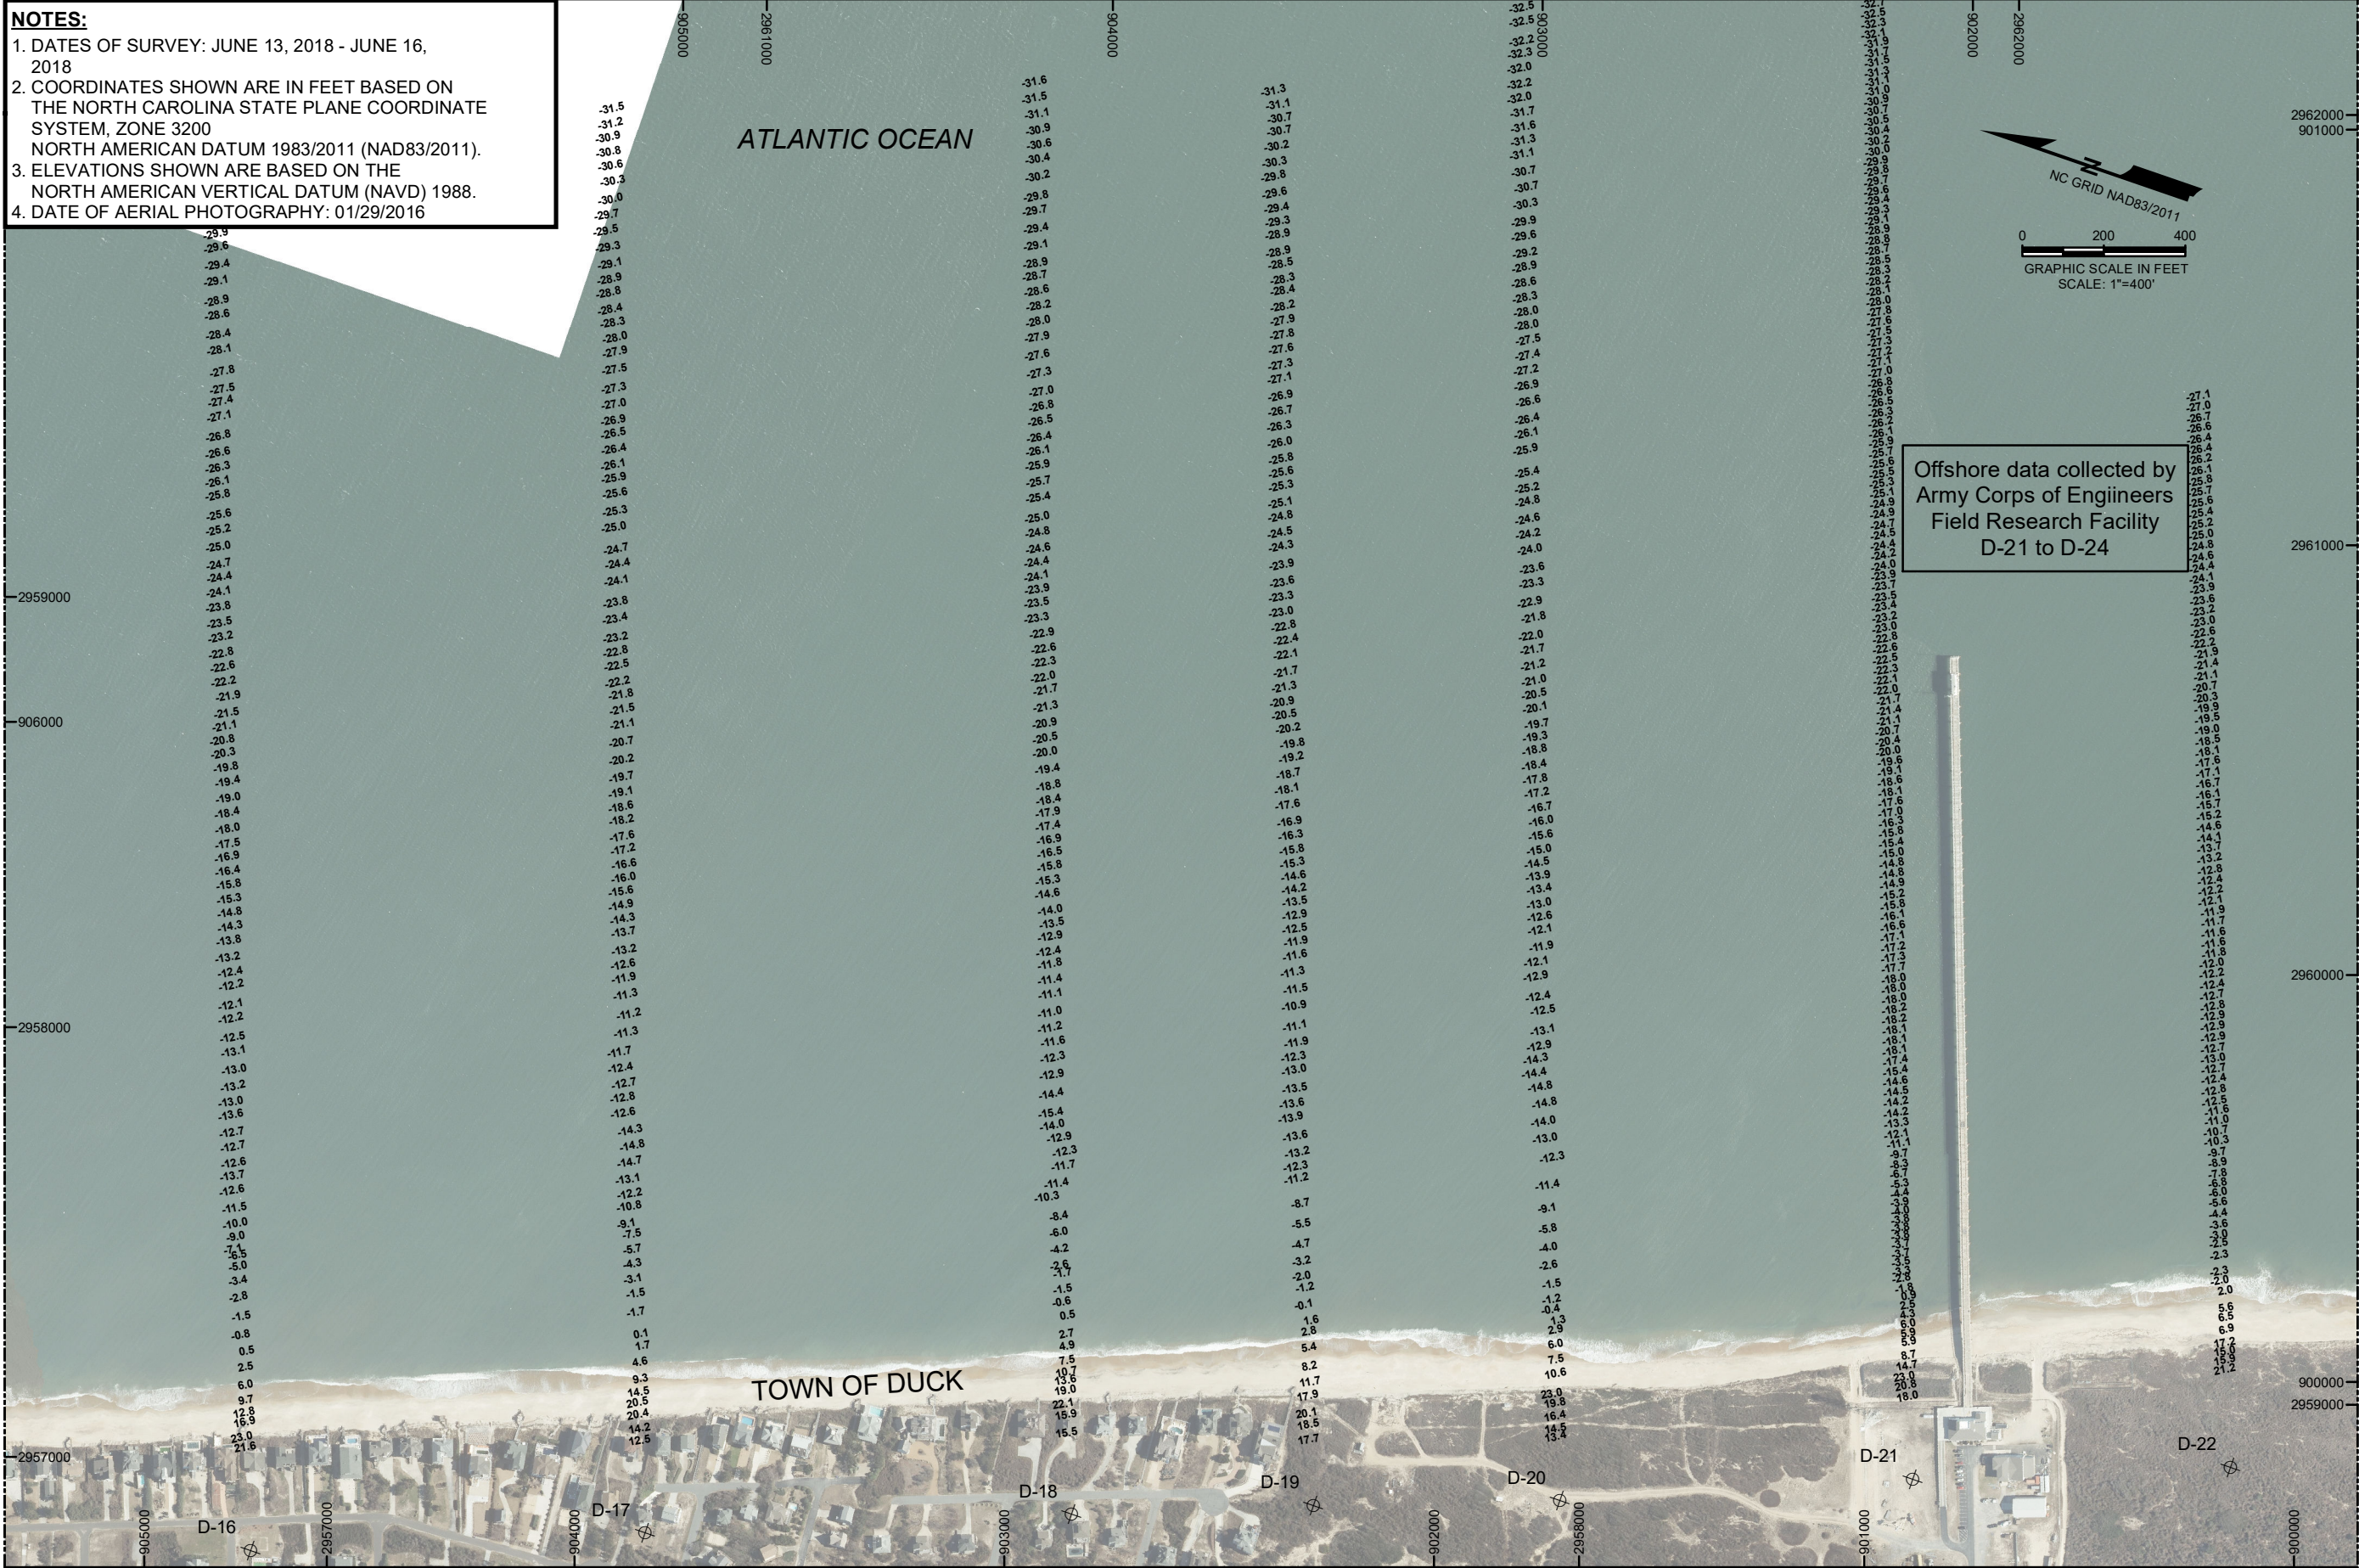
Offshore data collected by  
Army Corps of Engineers  
Field Research Facility  
D-21 to D-24

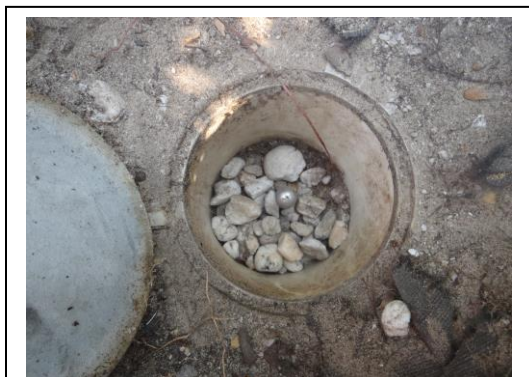
Monument: C255

<b>CONTROL MONUMENT USED BY APTIM FOR 2018 DARE COUNTY ANNUAL MONITORING TOPOGRAPHIC AND HYDROGRAPHIC SURVEY REPORT JUNE 2018</b>	
<b>DATUMS: NAD83/2011 - NAVD1988</b>	
<b>Designation</b>	C255
<b>Stamping</b>	C255 1981
<b>Northing</b>	900856.11
<b>Easting</b>	2958600.06
<b>Horizontal Root Mean Square Error</b>	0.230
<b>Elevation</b>	16.89
<b>Vertical Root Mean Square Error</b>	0.114
<b>Description</b>	A National Geodetic Survey pin inside a protective casing with lid approximately 3 inches below ground and located between the two steps on the West side of the Army Corp of Engineer's Field Research Facility (1261 Duck Road), approximately 355 feet East of the main parking lot gate, 15 feet South of the Northerly steps, 15 feet North of the Southerly steps, and 2.7 feet West of the flag pole.

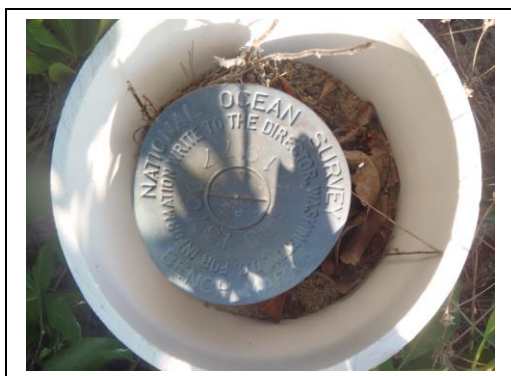
Monument: TIDAL C

<b>CONTROL MONUMENT USED BY APTIM FOR 2018 DARE COUNTY ANNUAL MONITORING TOPOGRAPHIC AND HYDROGRAPHIC SURVEY REPORT JUNE 2018</b>	
<b>DATUMS: NAD83/2011 - NAVD1988</b>	
<b>Designation</b>	TIDAL C
<b>Stamping</b>	865 1370 1977
<b>Northing</b>	900621.51
<b>Easting</b>	2957662.02
<b>Horizontal Root Mean Square Error</b>	0.229
<b>Elevation</b>	18.46
<b>Vertical Root Mean Square Error</b>	0.015
<b>Description</b>	A National Ocean Survey disk protected by an open pipe approximately 6 inches above ground and located on the Army Corp of Engineer's Field Research Facility property (1261 Duck Road) approximately 600 feet East of Duck Road, 300 feet West of the gazebo, and 100 feet North of the access road.
