**TOWN OF DUCK NORTH CAROLINA
SHORELINE & VOLUME CHANGE
MONITORING REPORT**

May 2018

2017 TOWN OF DUCK SHORELINE & VOLUME MONITORING REPORT

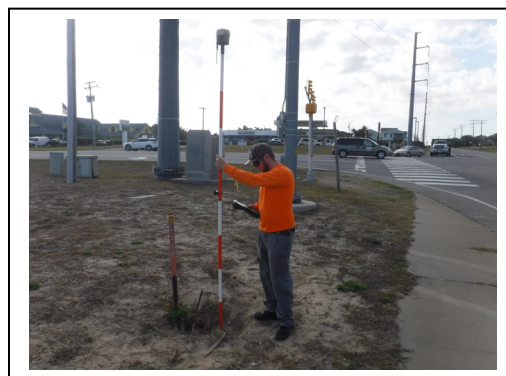
Monument: L230

Mean of Inverse Shots - Published Versus APTIM Found				
Monument	No. of Shots	ΔN	ΔE	ΔZ
ARCH	16	-0.01	-0.01	-0.06

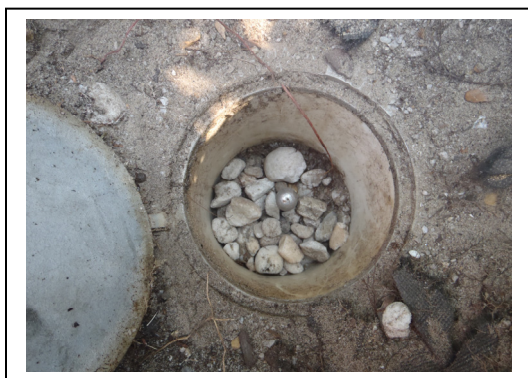
Monument: C255

CONTROL MONUMENT USED BY APTIM FOR 2017 TOWN OF DUCK BEACH PROFILE TOPOGRAPHIC AND HYDROGRAPHIC SURVEY REPORT FEBRUARY 2017	
DATUMS: NAD83/2011 - NAVD1988	
Designation	C255
Stamping	C255 1981
Northing	900856.11
Easting	2958600.06
Horizontal Root Mean Square Error	0.106
Elevation	16.89
Vertical Root Mean Square Error	0.014
Description	A National Geodetic Survey pin inside a protective casing with lid approximately 3 inches below ground and located between the two steps on the West side of the Army Corp of Engineer's Field Research Facility (1261 Duck Road), approximately 355 feet East of the main parking lot gate, 15 feet South of the Northerly steps, 15 feet North of the Southerly steps, and 2.7 feet West of the flag pole.

Mean of Inverse Shots - Published Versus APTIM Found				
Monument	No. of Shots	ΔN	ΔE	ΔZ
C255	28	0.01	0.06	-0.01

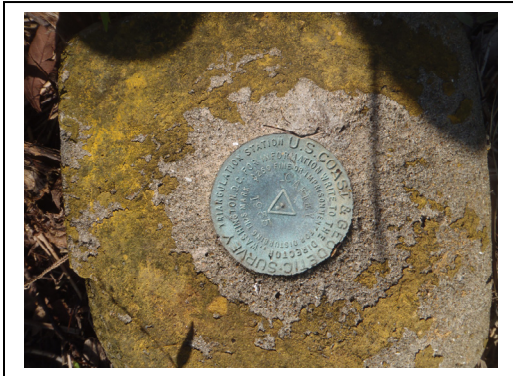
Monument: CAFFEY

CONTROL MONUMENT USED BY APTIM FOR 2017 TOWN OF DUCK BEACH PROFILE TOPOGRAPHIC AND HYDROGRAPHIC SURVEY REPORT NOVEMBER 2017	
DATUMS: NAD83/2011 - NAVD1988	
Designation	CAFFEY
Stamping	CAFFEY 1935
Northing	915308.87
Easting	2952084.11
Horizontal Root Mean Square Error	0.254
Elevation	1.99
Vertical Root Mean Square Error	0.051
Description	A U.S. Coast & Geodetic Survey disk in concrete located in thick vegetation approximately 140 feet West of Duck Road and 40 feet South of a parking lot for 1566 Duck Road

Mean of Inverse Shots - Published Versus APTIM Found				
Monument	No. of Shots	ΔN	ΔE	ΔZ
CAFFEY	19	-0.01	0.01	0.05

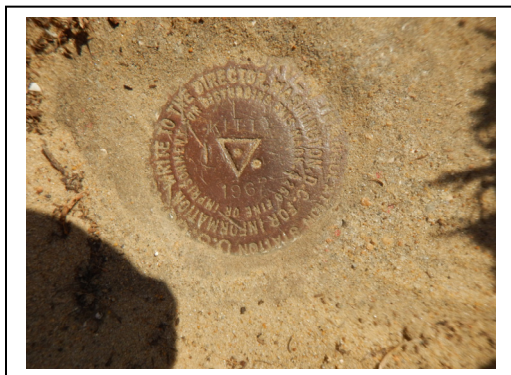
Monument: KITTY

CONTROL MONUMENT USED BY APTIM FOR 2017 TOWN OF DUCK BEACH PROFILE TOPOGRAPHIC AND HYDROGRAPHIC SURVEY REPORT NOVEMBER 2017	
DATUMS: NAD83/2011- NAVD1988	
Designation	KITTY
Stamping	KITTY 1962
Northing	849159.56
Easting	298928.60
Horizontal Root Mean Square Error	0.147
Elevation	9.17
Vertical Root Mean Square Error	0.036
Description	Located about 0.65 miles east of the post office in kitty hawk. A Standard disk set in a 12x12 inch concrete monument and tamped Kitty 1962 is 12 feet east-southeast of the intersection. The mark is flush with ground.

Mean of Inverse Shots – OPUS Solution Versus APTIM Found				
Monument	No. of Shots	ΔN	ΔE	ΔZ
KITTY	18	0.01	0.01	-0.03

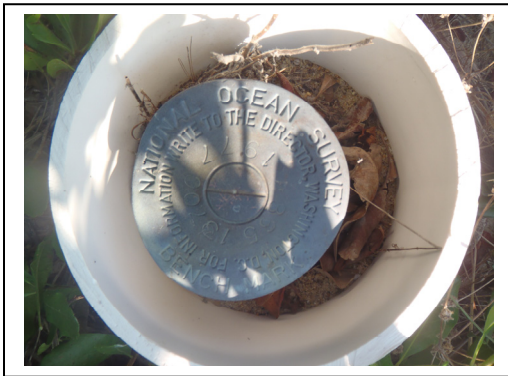
Monument: Tidal C

CONTROL MONUMENT USED BY APTIM FOR 2017 TOWN OF DUCK BEACH PROFILE TOPOGRAPHIC AND HYDROGRAPHIC SURVEY REPORT NOVEMBER 2017	
DATUMS: NAD83/2011 - NAVD1988	
Designation	TIDAL C
Stamping	865 1370 1977
Northing	900621.51
Easting	2957662.02
Horizontal Root Mean Square Error	0.147
Elevation	18.46
Vertical Root Mean Square Error	0.036
Description	A National Ocean Survey disk protected by an open pipe approximately 6 inches above ground and located on the Army Corp of Engineer's Field Research Facility property (1261 Duck Road) approximately 600 feet East of Duck Road, 300 feet West of the gazebo, and 100 feet North of the access road.

Mean of Inverse Shots – OPUS Solution Versus APTIM Found				
Monument	No. of Shots	ΔN	ΔE	ΔZ
TIDAL C	12	0.01	-0.01	0.00
