2023 Impact Analysis Town of Duck Duck, North Carolina

**COASTAL PROTECTION ENGINEERING
OF NORTH CAROLINA, INC.**
4038 MASONBORO LOOP ROAD
WILMINGTON, NC 28409
PH. (910) 399-1905

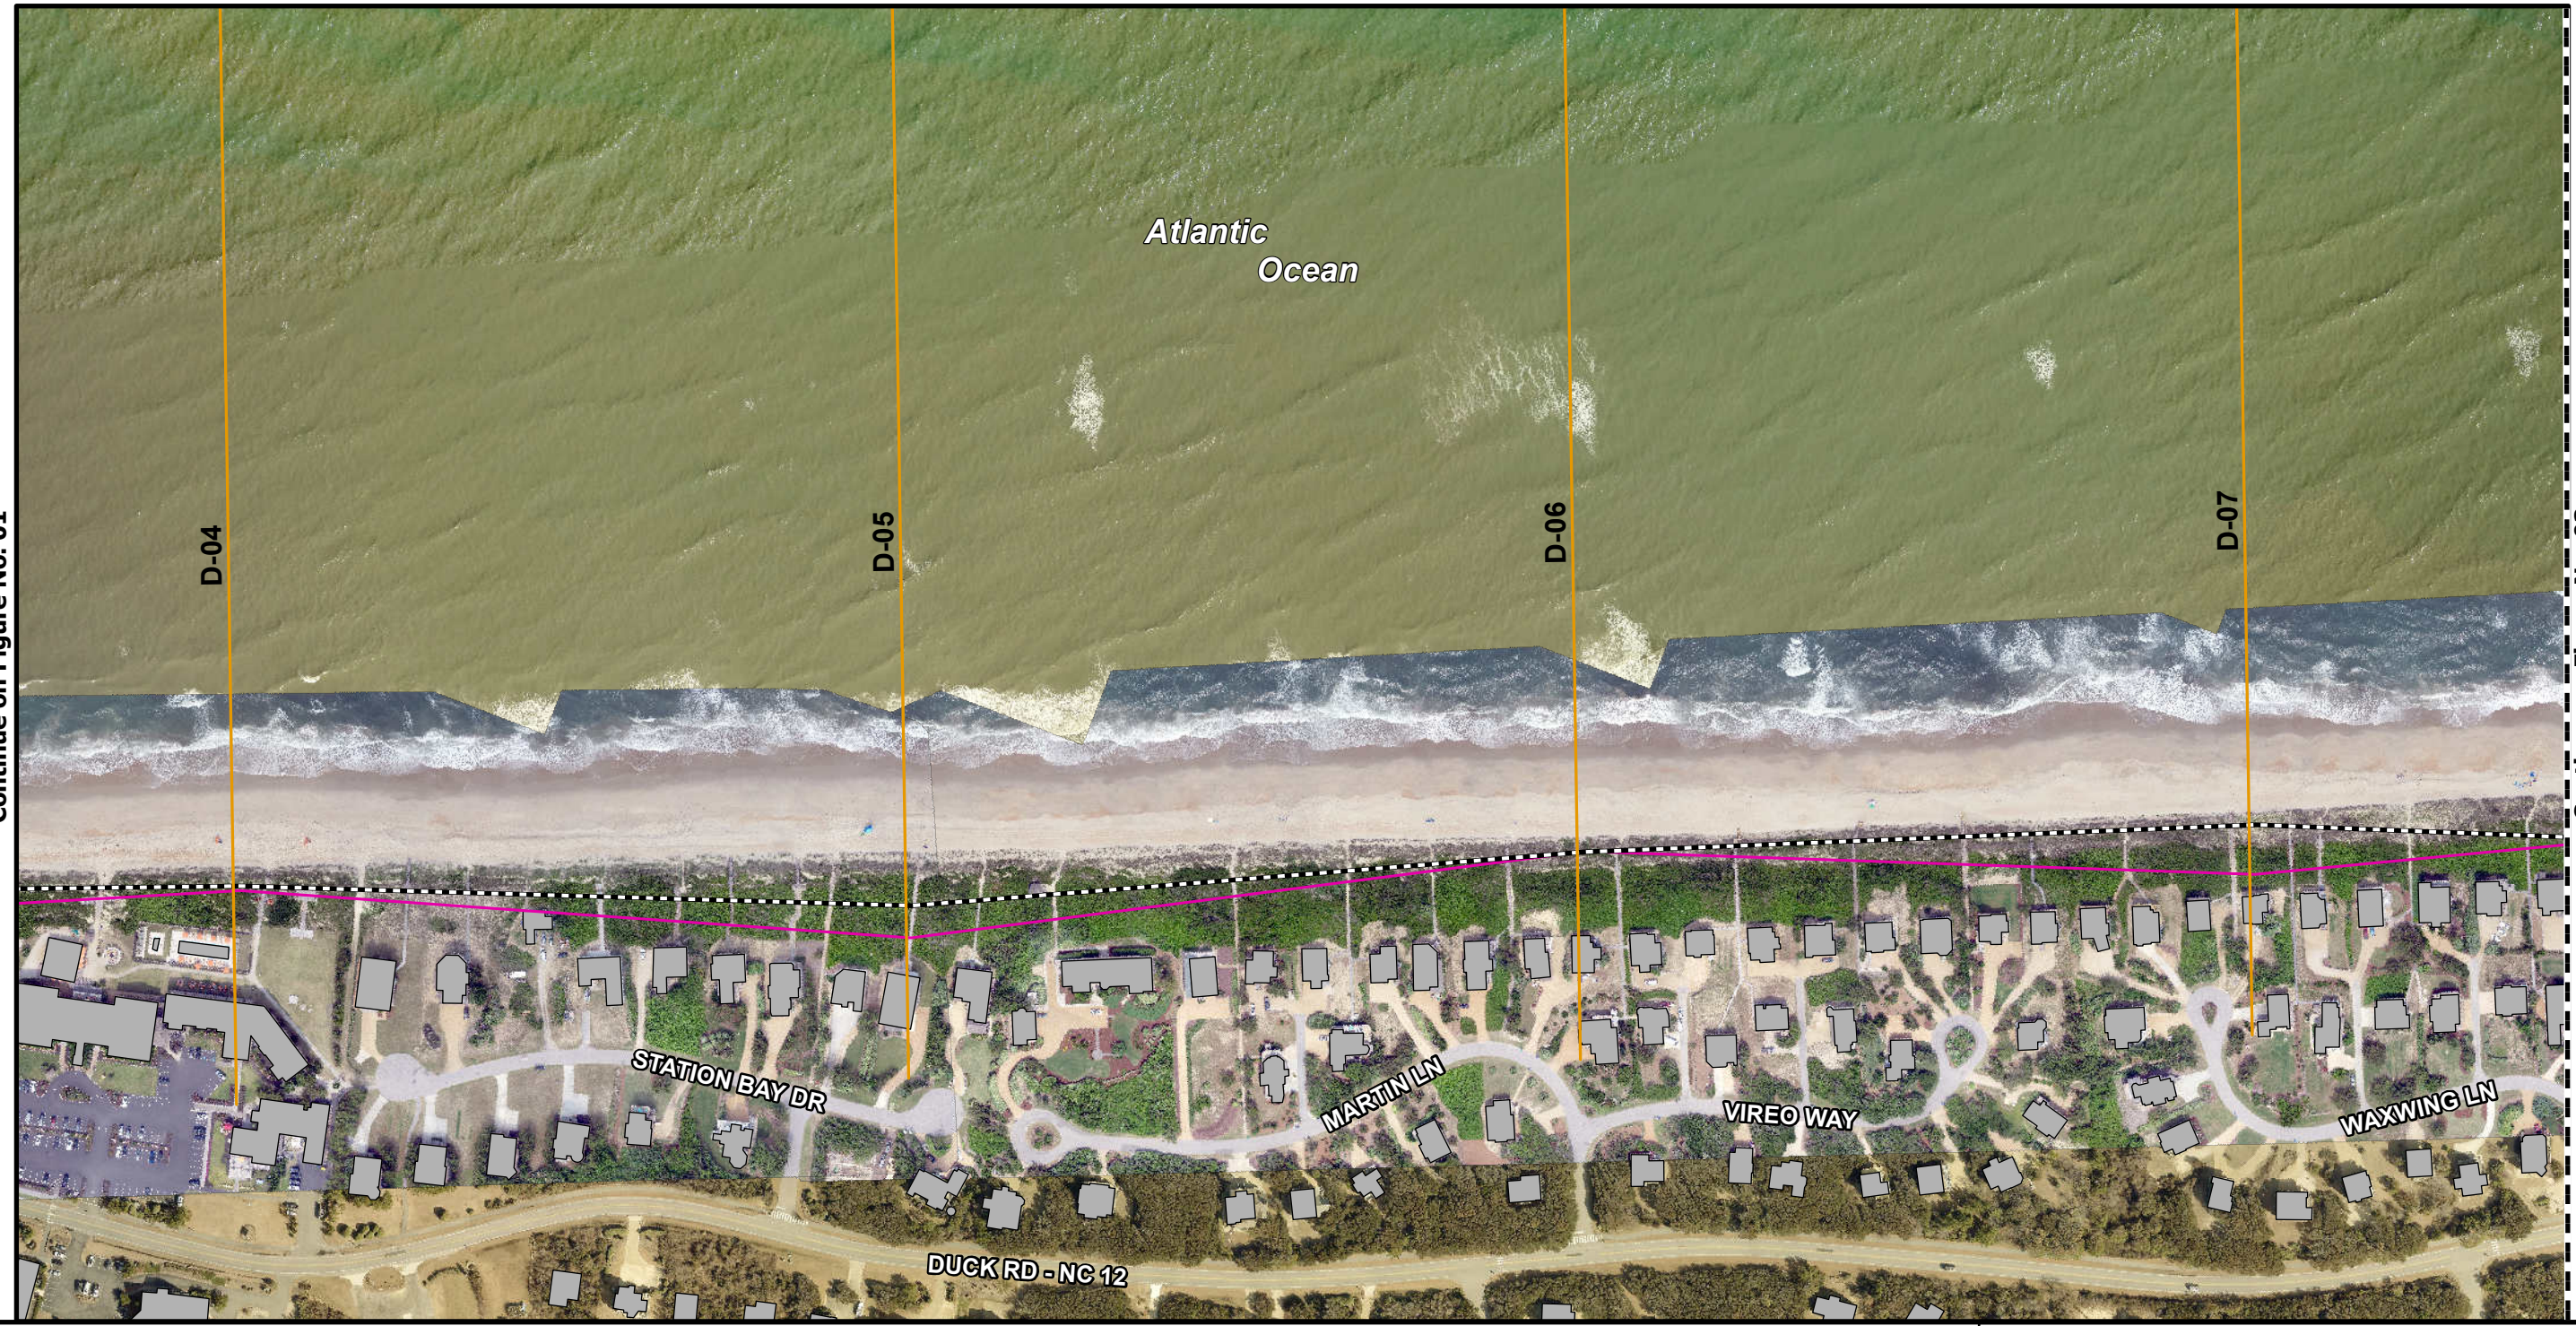
Figure No. 2

**2023 Impact Analysis
Town of Duck
Duck, North Carolina**

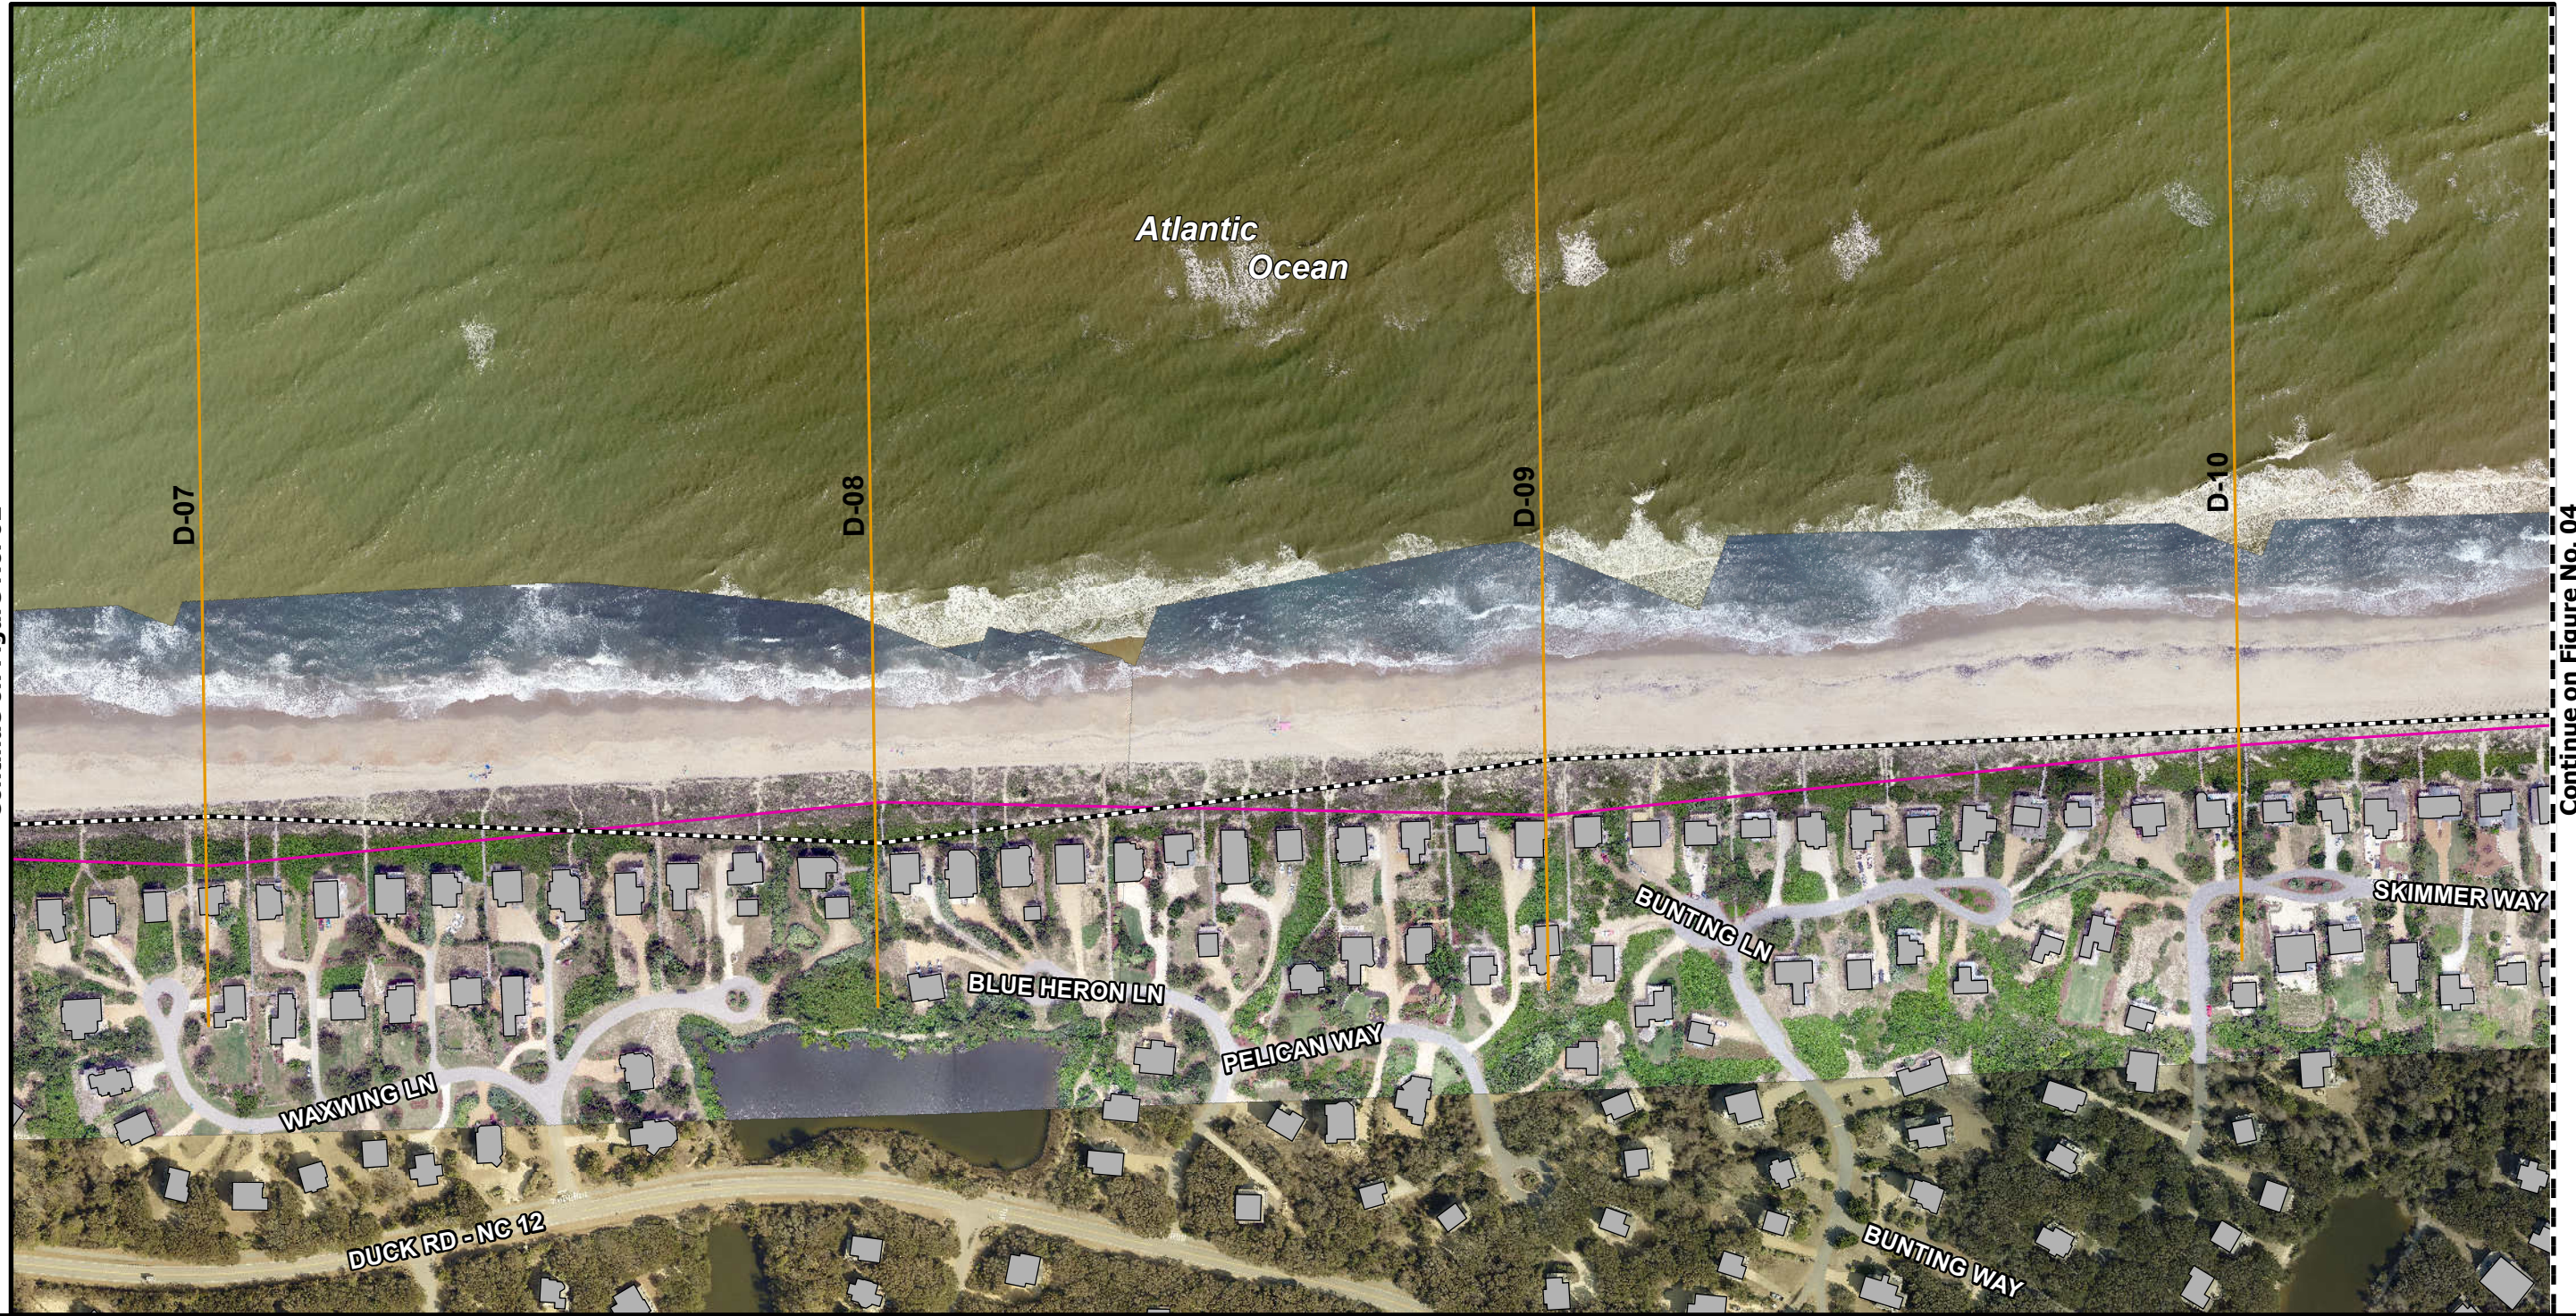
Figure No. 3

2023 Impact Analysis Town of Duck Duck, North Carolina

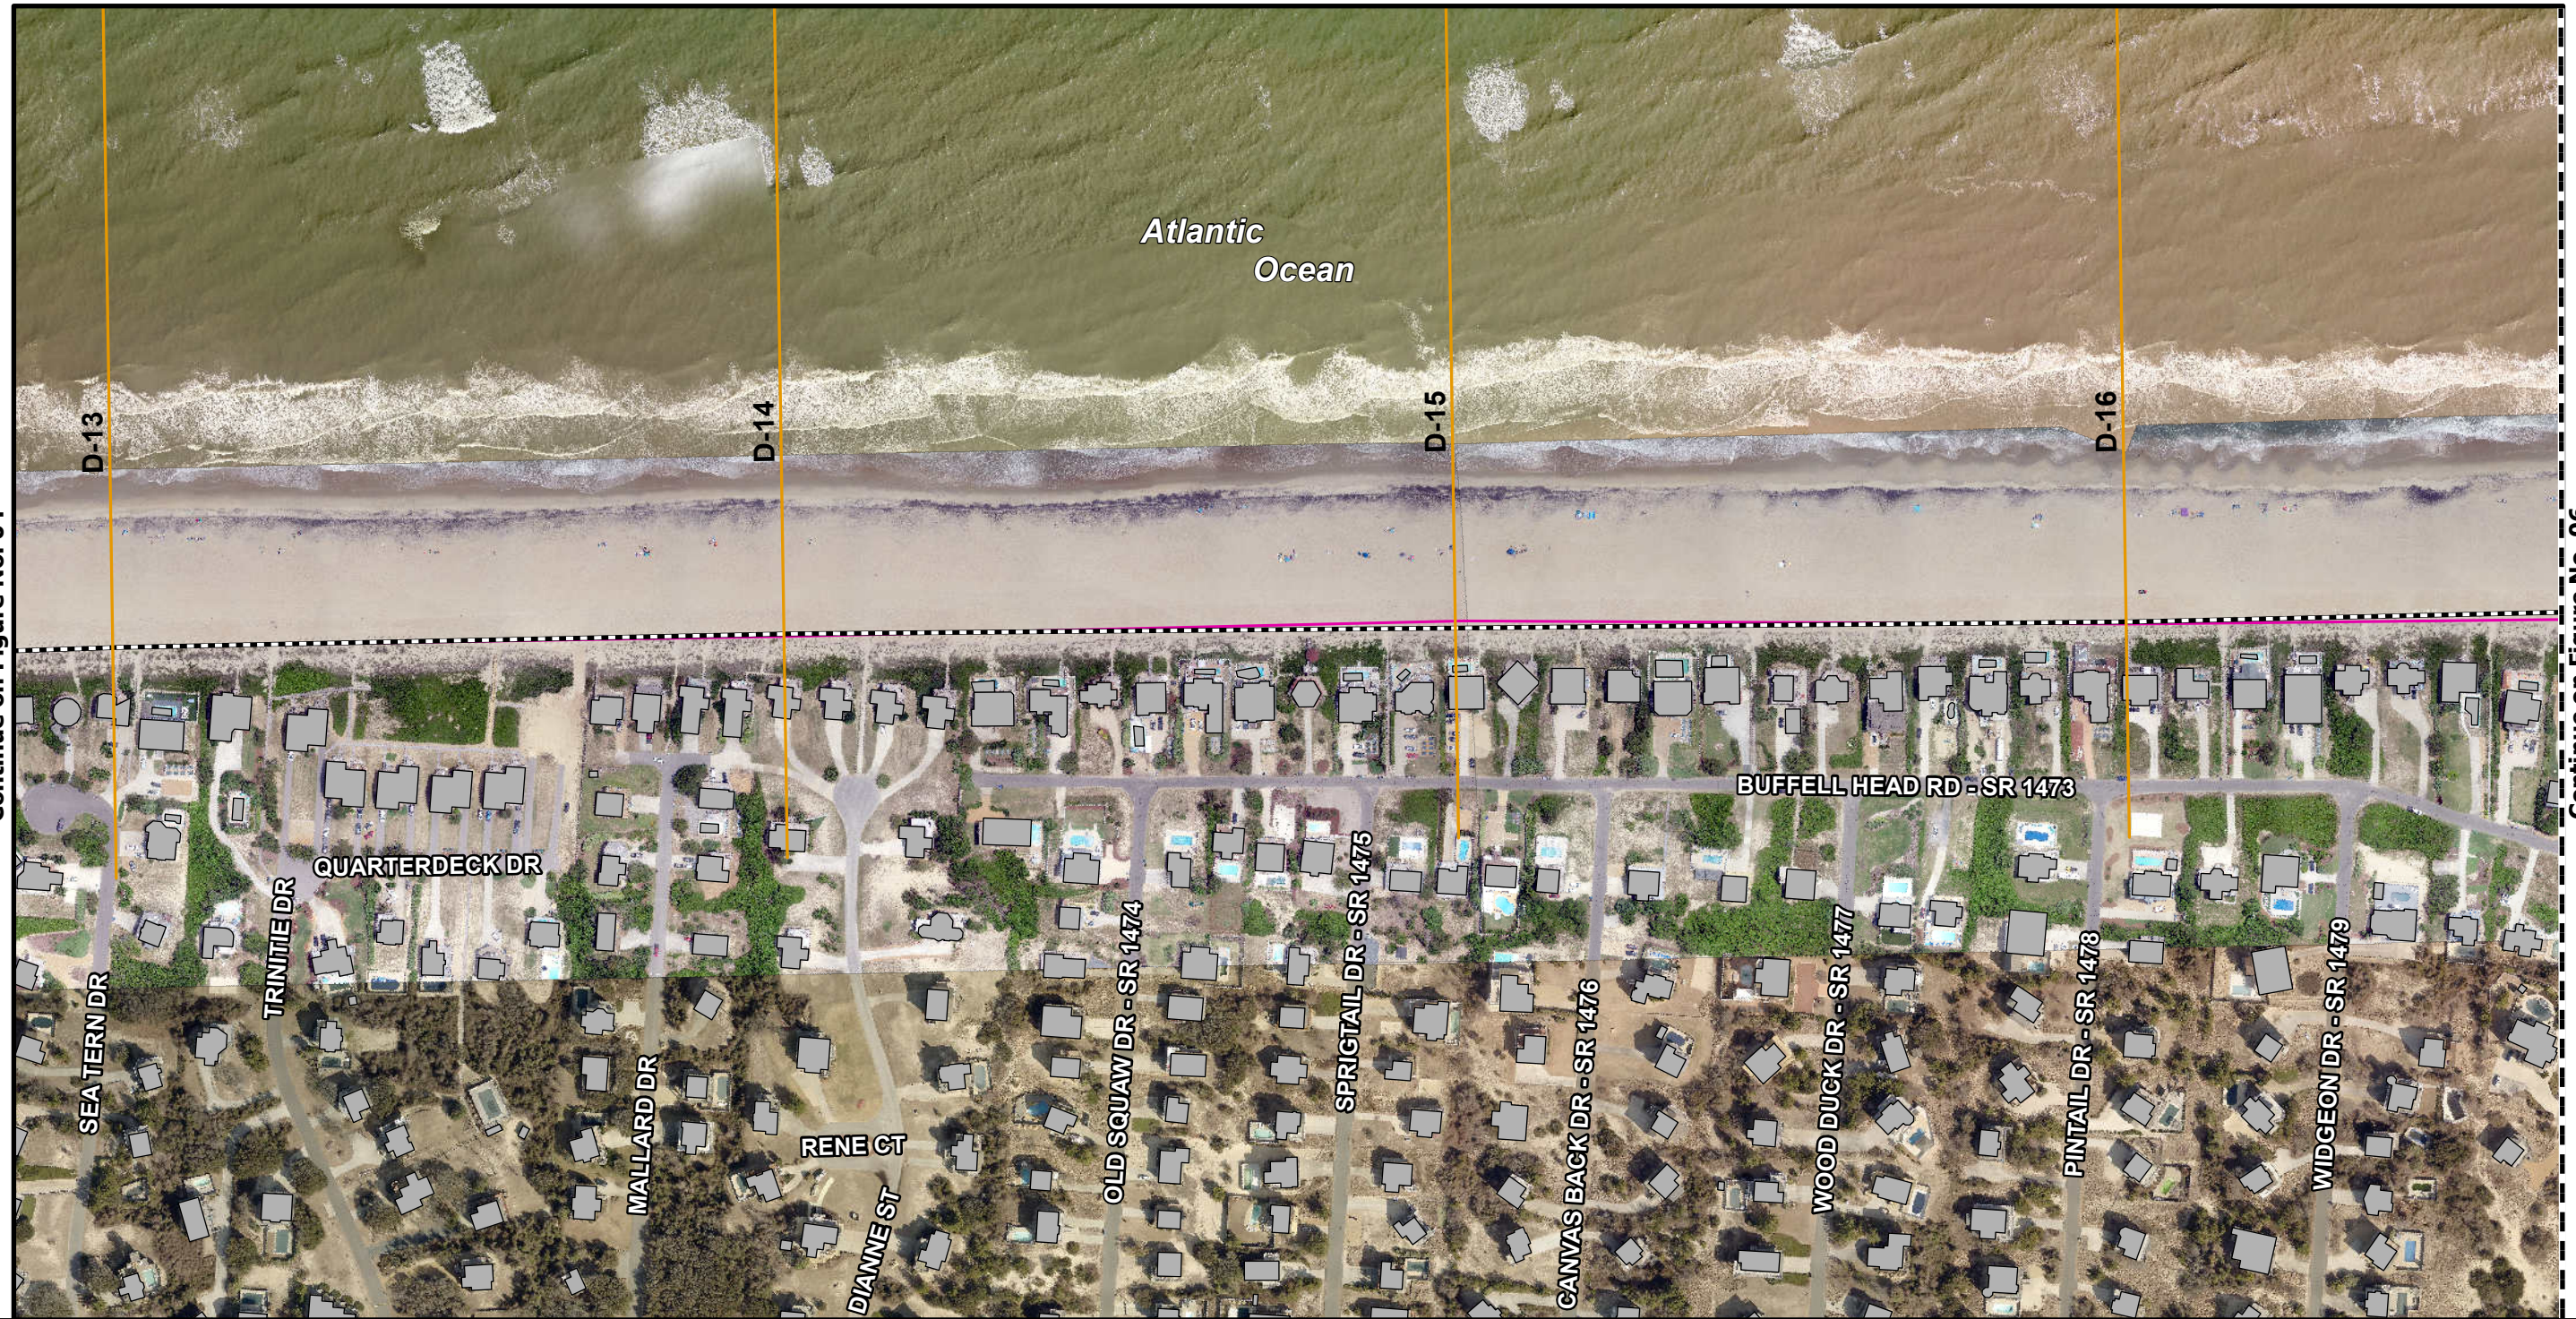
Figure No. 5

2023 Impact Analysis Town of Duck Duck, North Carolina

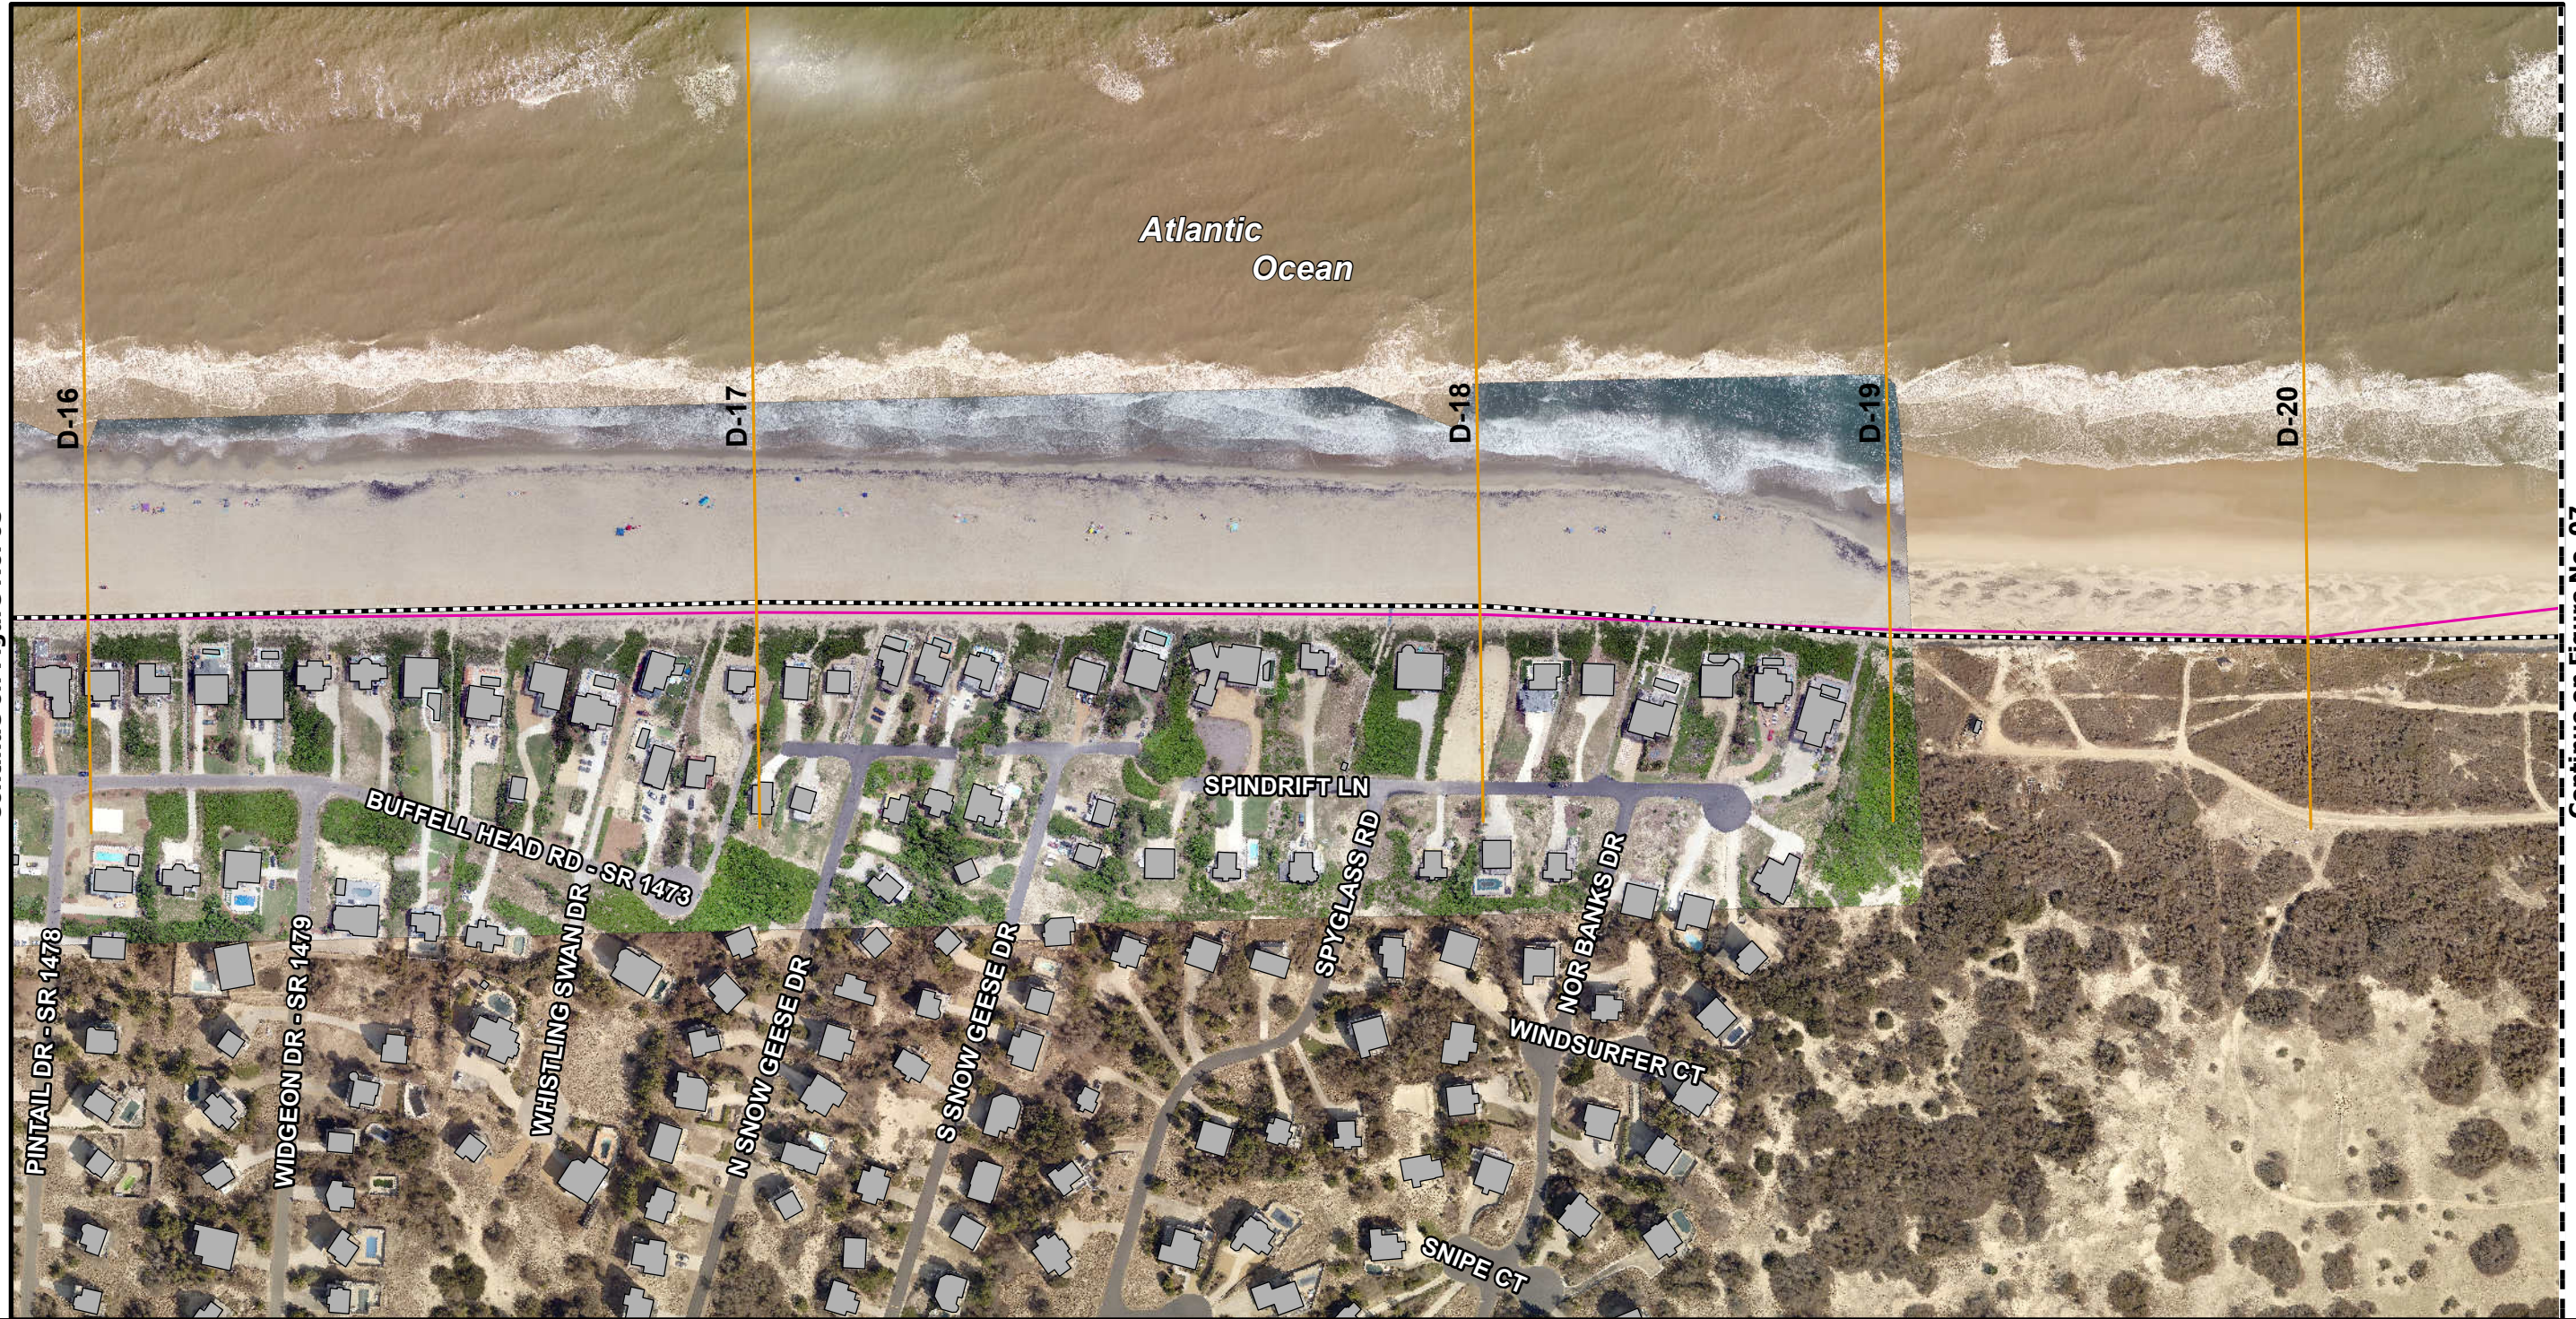
Figure No. 6

2023 Impact Analysis Town of Duck Duck, North Carolina

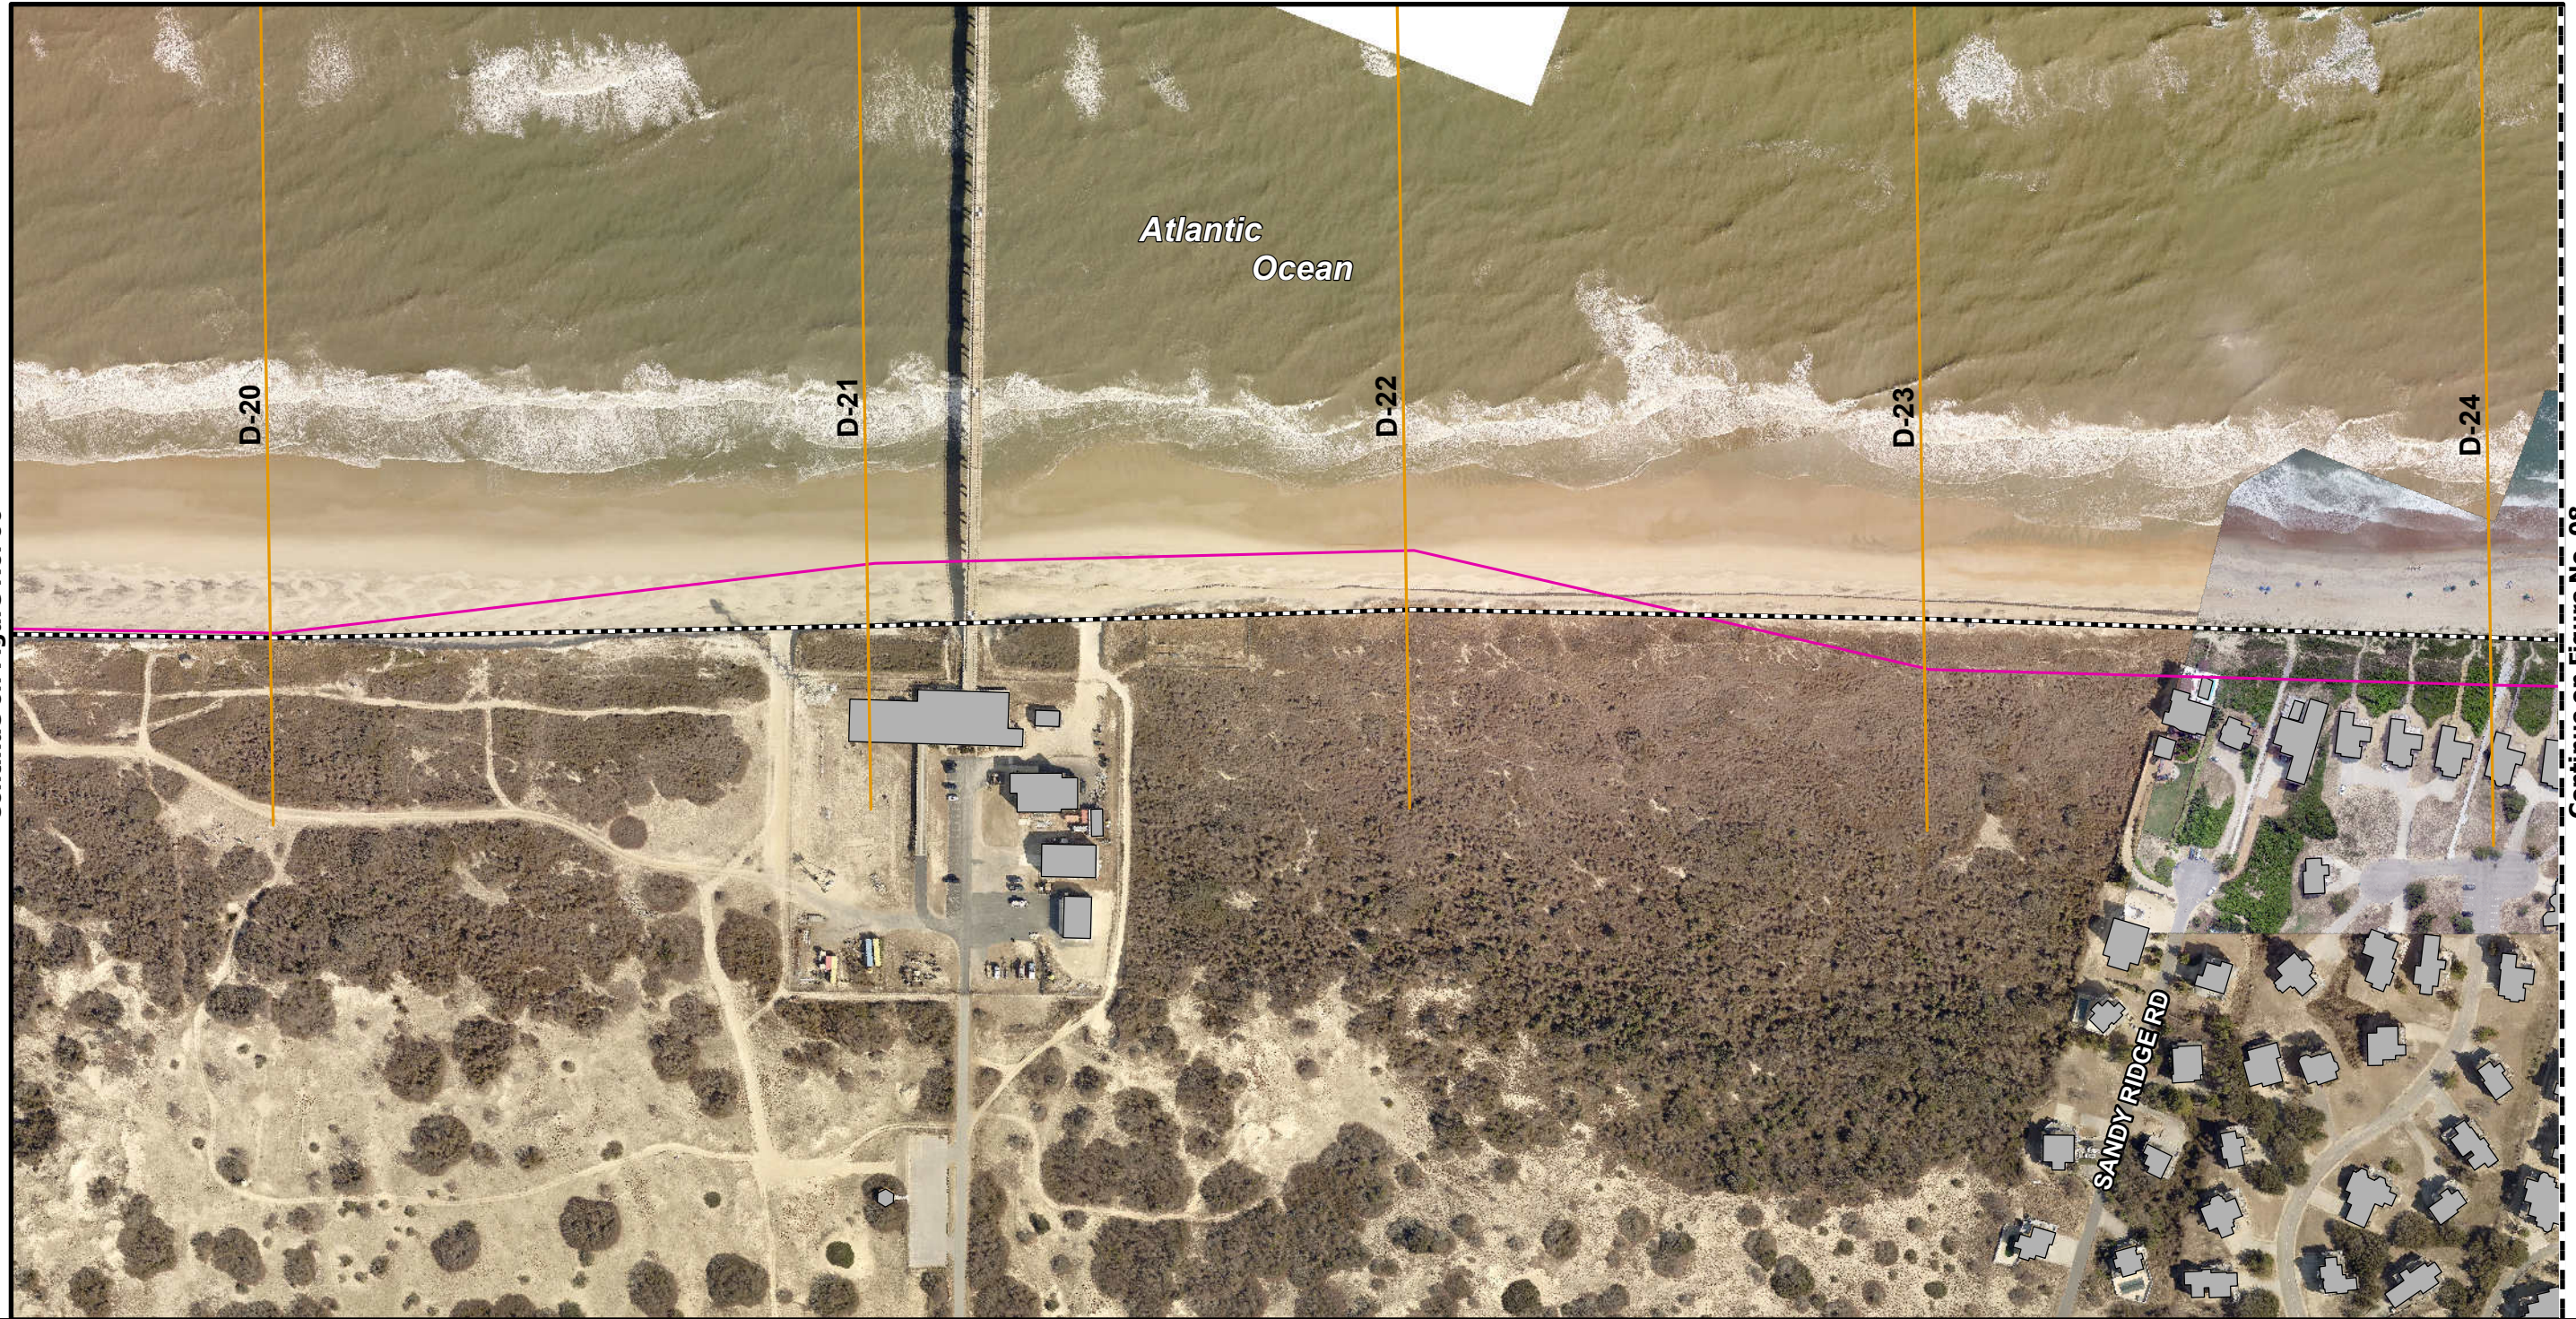
Figure No. 7

2023 Impact Analysis Town of Duck Duck, North Carolina

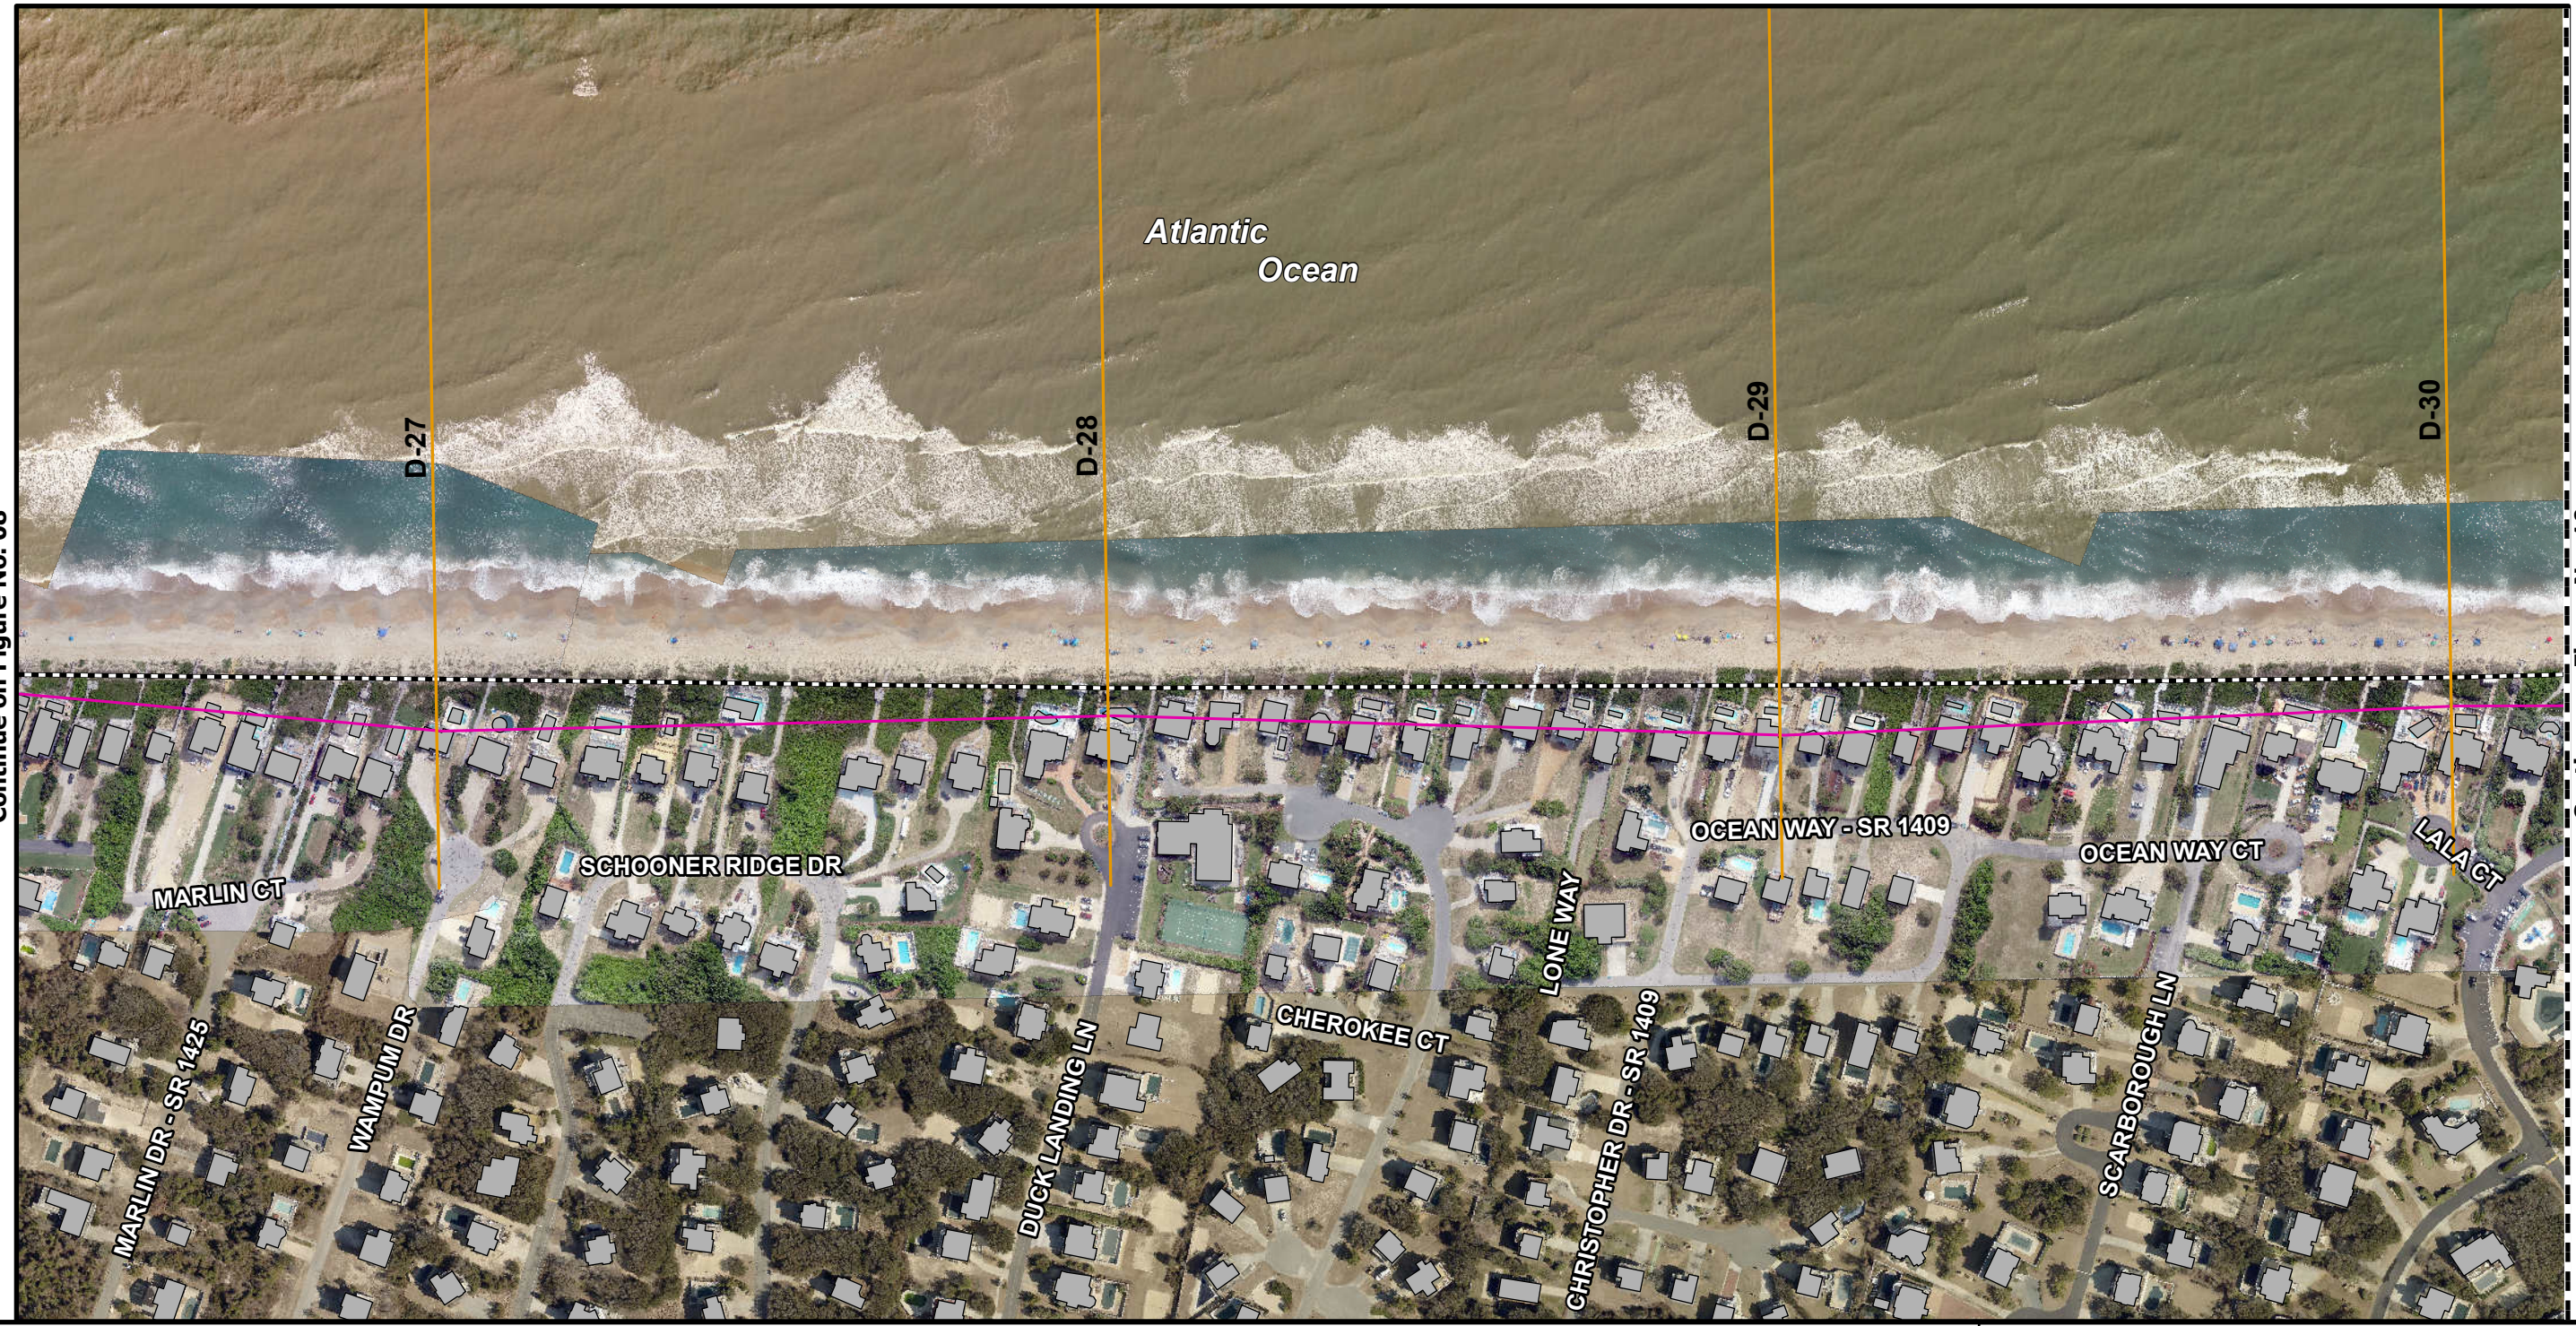
Date: 10/11/23	By: CM	Figure No. 9
----------------	--------	--------------

**2023 Impact Analysis
Town of Duck
Duck, North Carolina**
