2023 Impact Analysis Town of Duck Duck, North Carolina

**COASTAL PROTECTION ENGINEERING
OF NORTH CAROLINA, INC.**
4038 MASONBORO LOOP ROAD
WILMINGTON, NC 28409
PH. (910) 399-1905

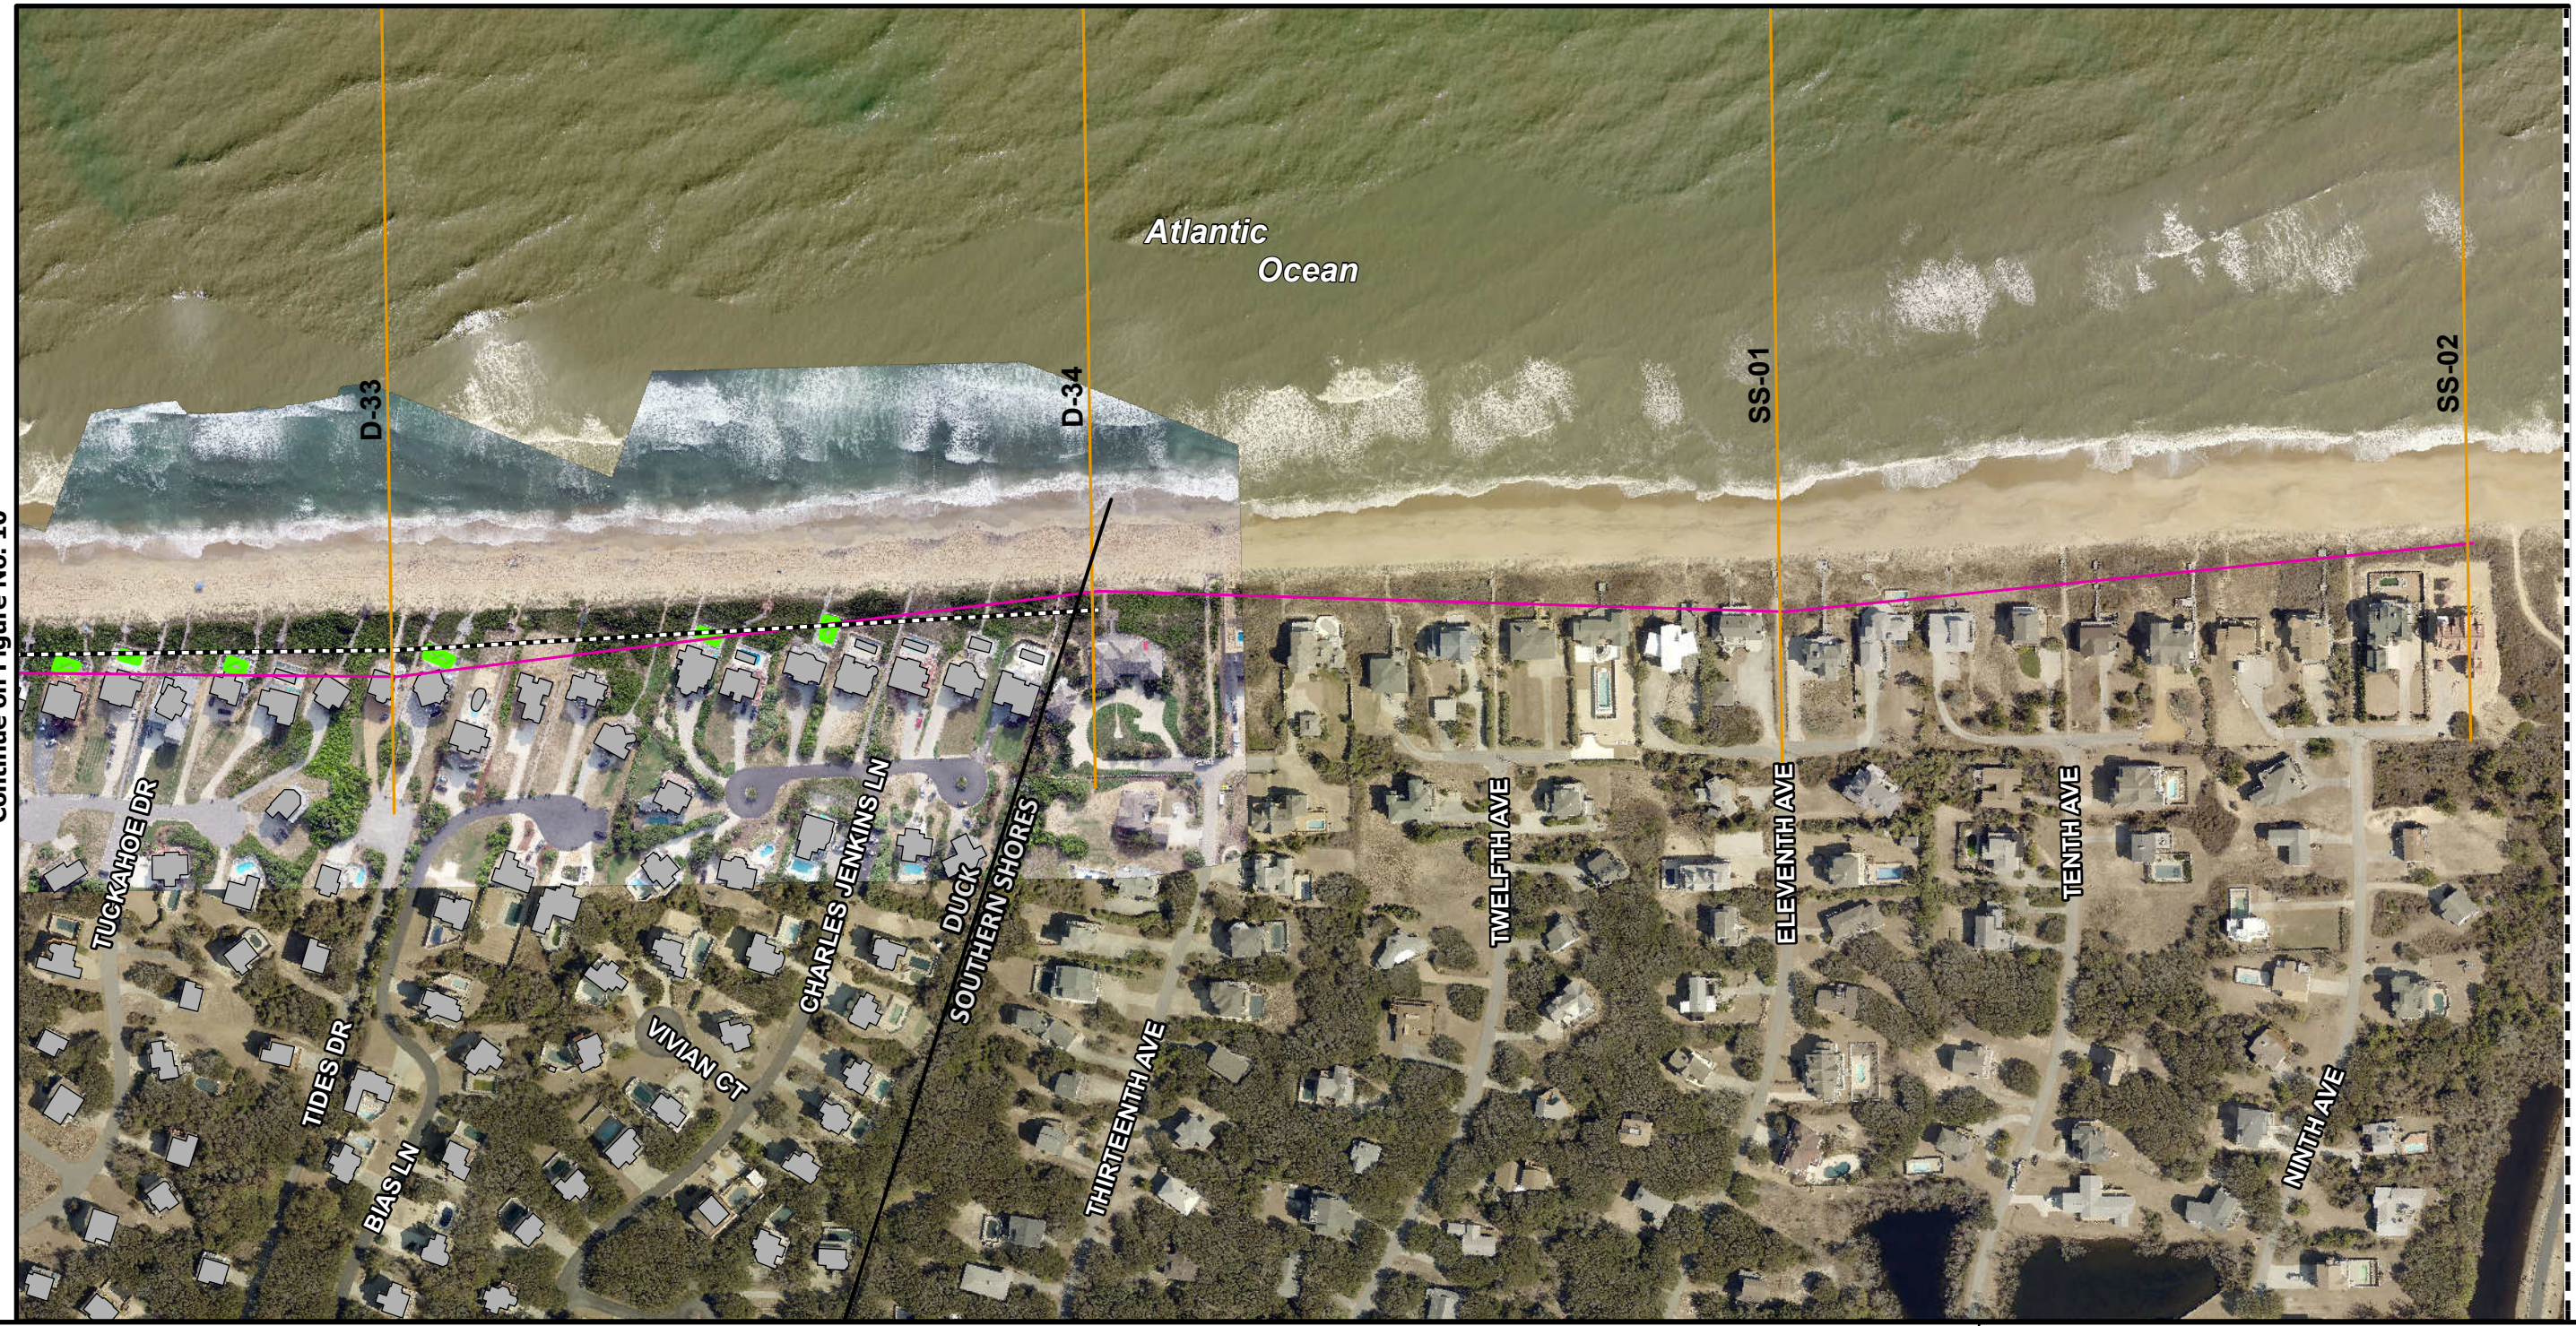
TITLE: 2023 Impact Analysis Town of Duck Duck, North Carolina		
COASTAL PROTECTION ENGINEERING OF NORTH CAROLINA, INC. 4038 MASONBORO LOOP ROAD WILMINGTON, NC 28409 PH. (910) 399-1905		
Date: 10/11/23	By: CM	Figure No. 11
