### III. SURVEY DATA COLLECTION

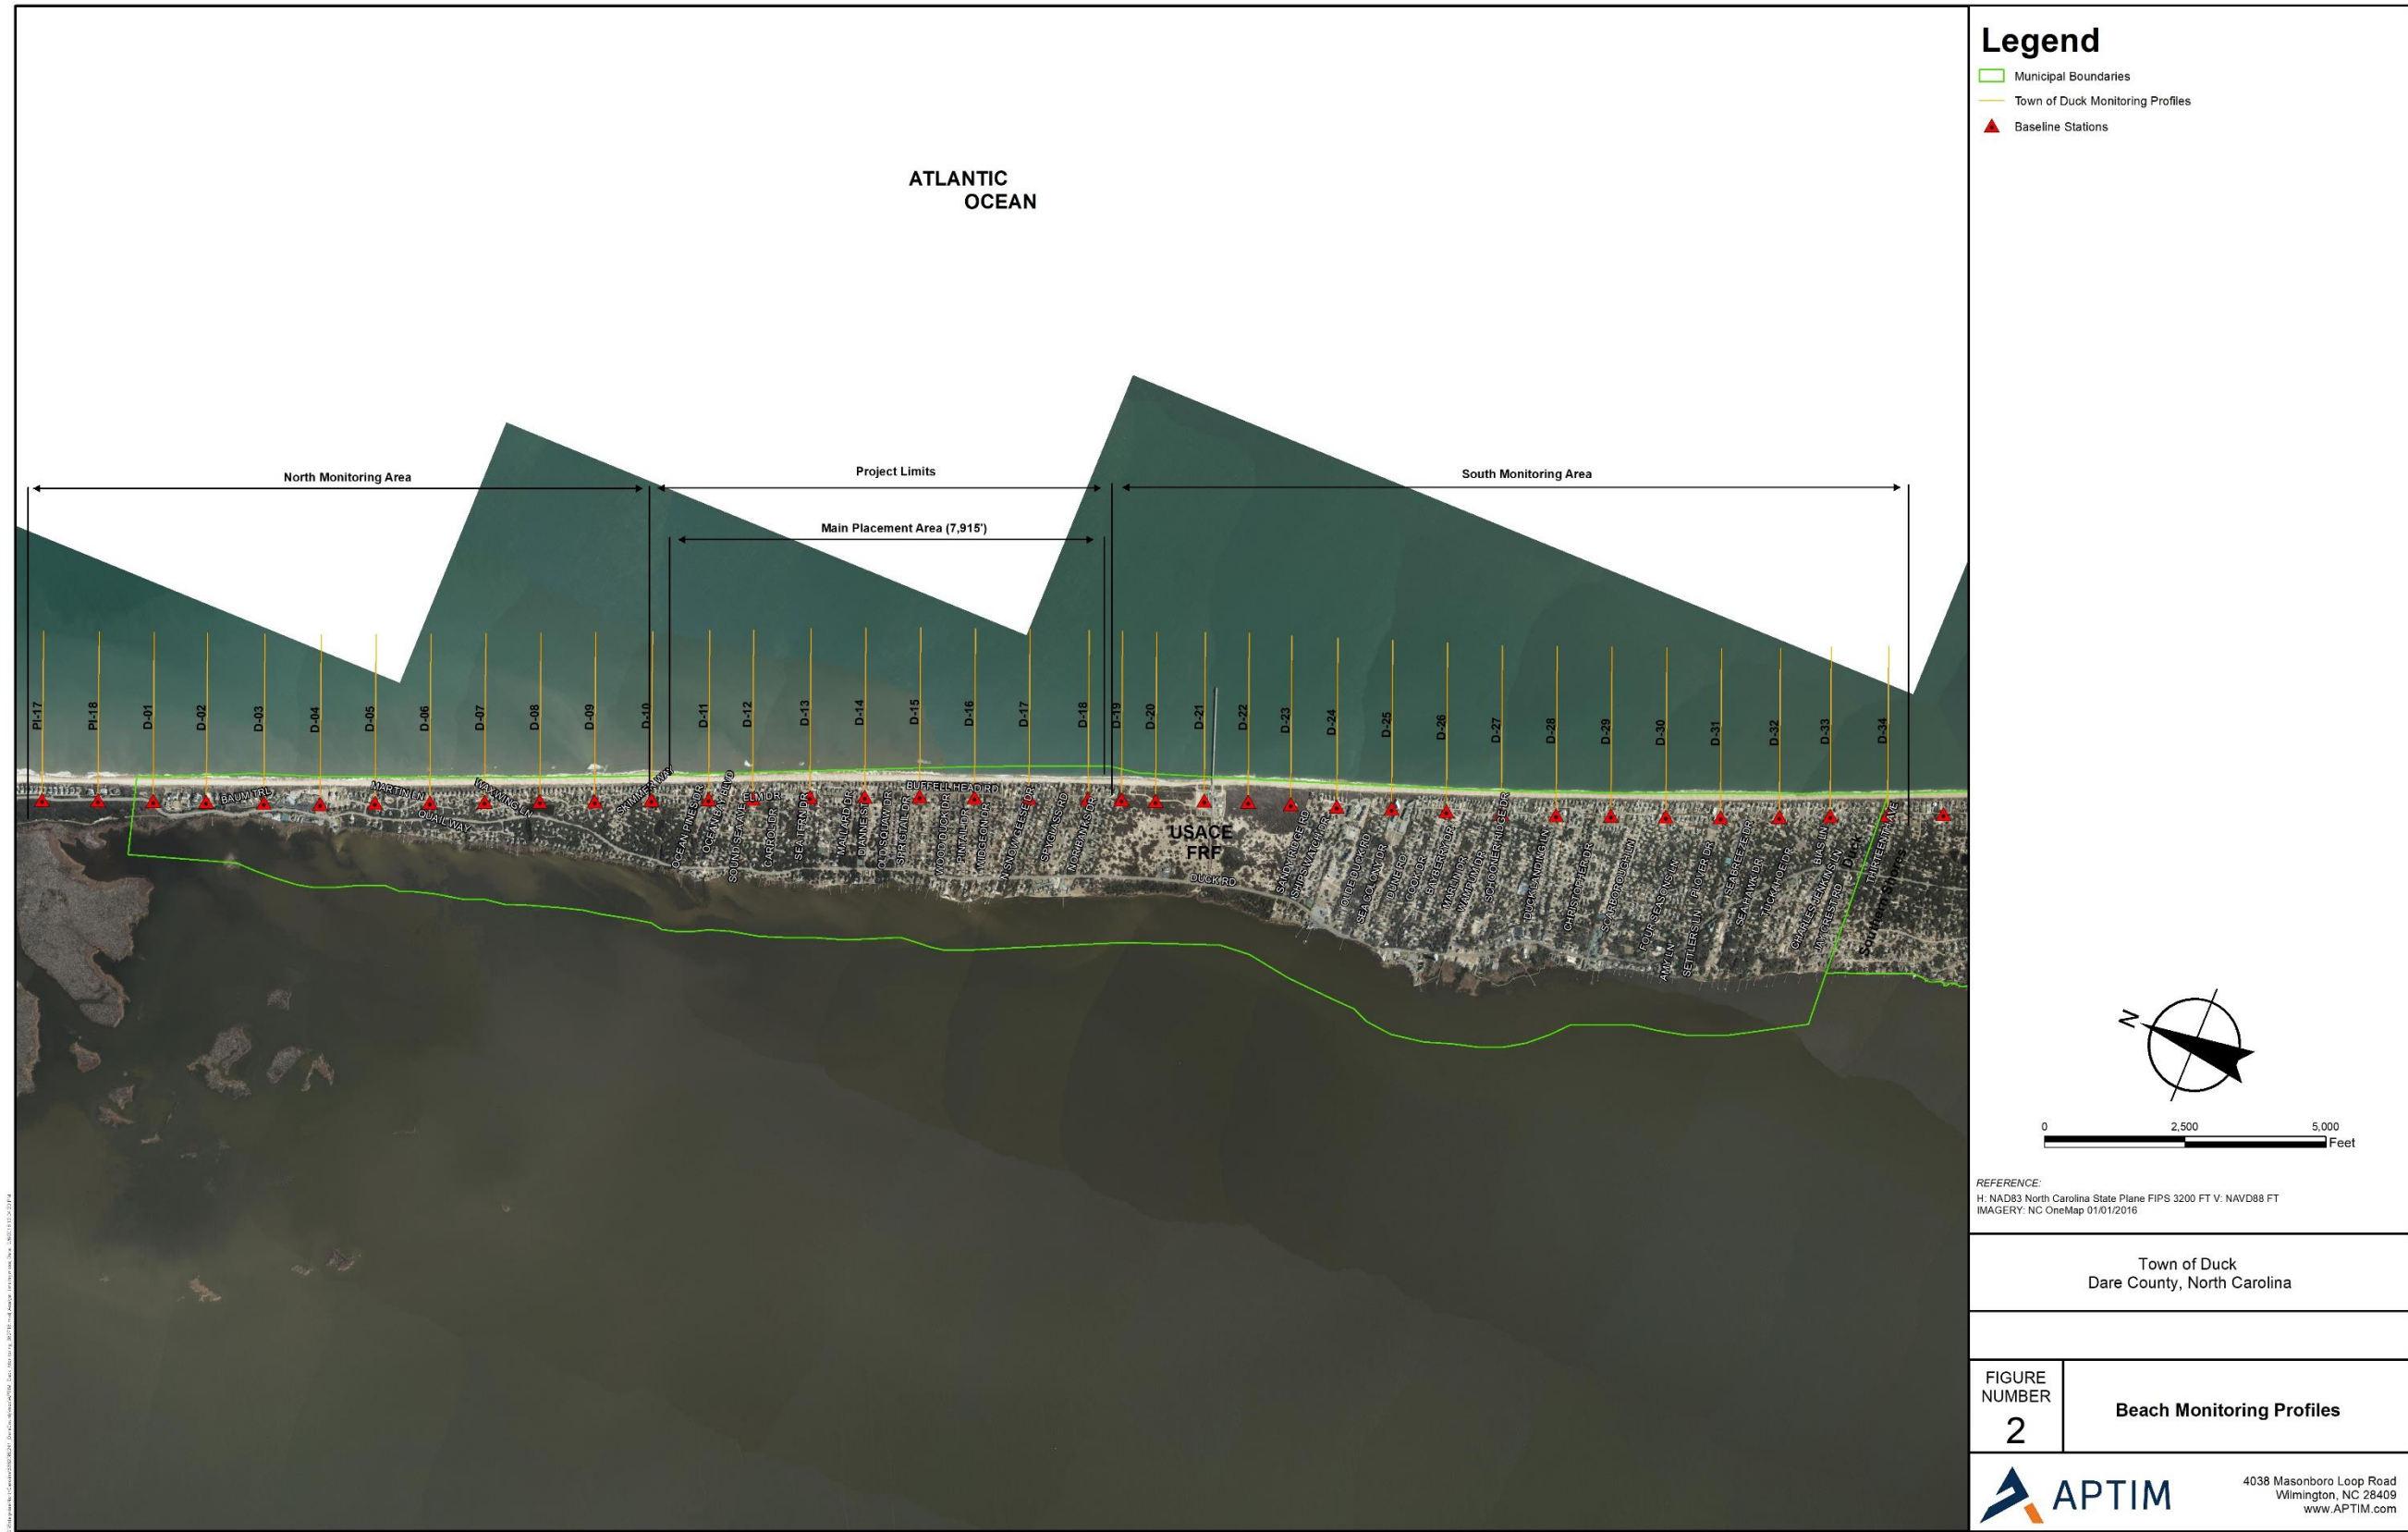
Figure 2. Detailed project area map showing the Project Area, North Monitoring Area, South Monitoring Area, and the location of the monitoring profiles.

Survey data were collected along transects listed in Table 1. Coordinates shown in Table 1 are referenced to the North Carolina State Plane coordinate system in feet NAD83 and the profile azimuth refers to degrees referenced to true north. Transects listed in Table 1 are shown graphically in Appendix A – 2018 Town of Duck Monitoring Survey Report. Appendix A also includes detailed survey methodology, monument information, profile plots, ground digital photography, and field book notes.
